Appendix D

Phase I Site Reconnaissance, Field Notes, Photographs, and Photo Logs Part 2

<p>California High Speed Train</p>	<p>Fresno to Bakersfield Baseline Conditions Report Bowen Engineering & Environmental 4664 S Cedar, Fresno, CA 93725</p>	<p>URS Project No. 27560811.53090100 Date: 3-16-10</p>
---	---	--

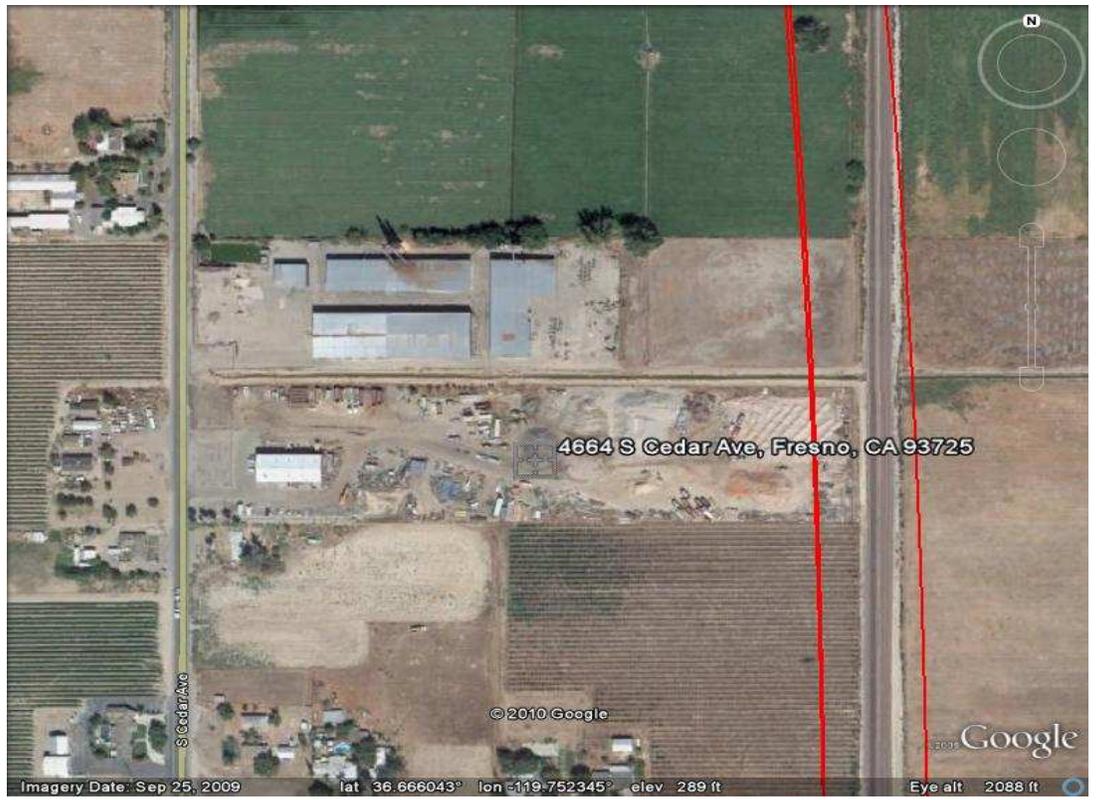
<p>Photo No. 2</p>	
<p>Direction Photo Taken: Aerial view; north at the top of frame</p>	
<p>Description: West end of the site along Cedar Avenue. Prominent feature is the remodeled office and shop building. Note empty ASTs and irrigation ditch along the north boundary of the site, and the stormwater retention basin southeast of the shop.</p>

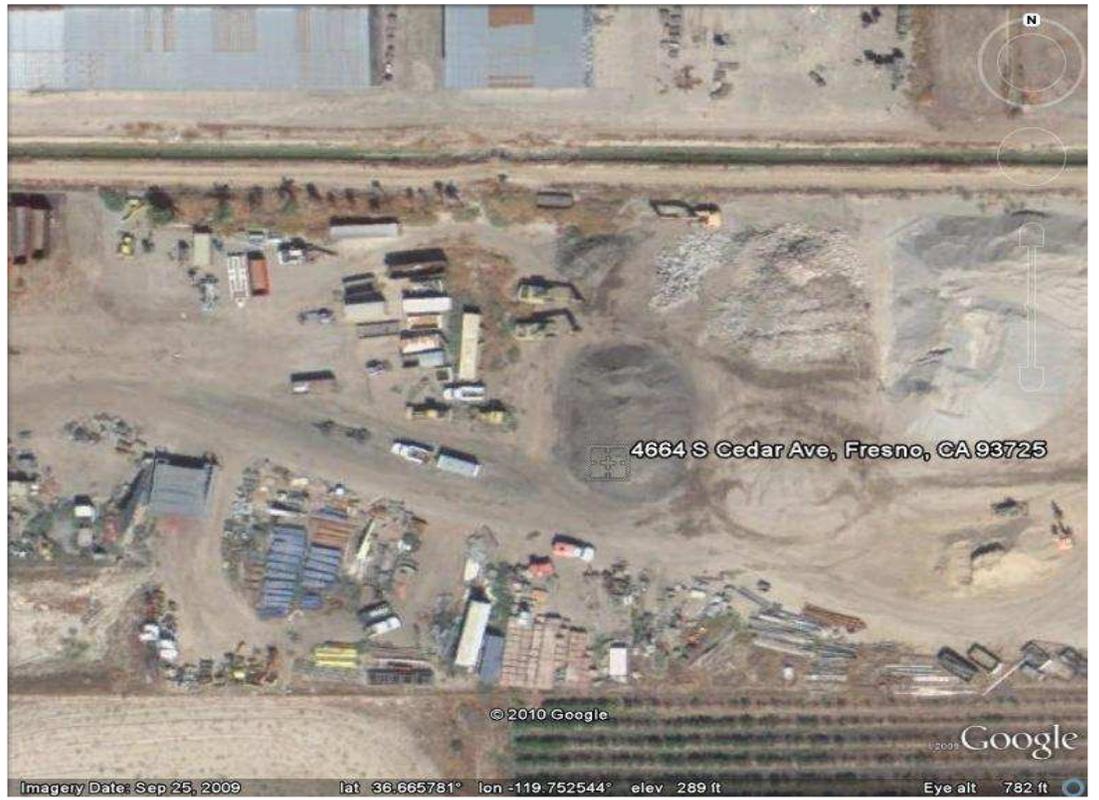
<p>Photo No. 4</p>
<p>Direction Photo Taken: Aerial view; north at the top of frame</p>
<p>Description: East end of the site. Proposed CAHST alignments (red) and the BNSF tracks are visible to the right of the frame. Concrete/asphalt and used brick recycling.</p>

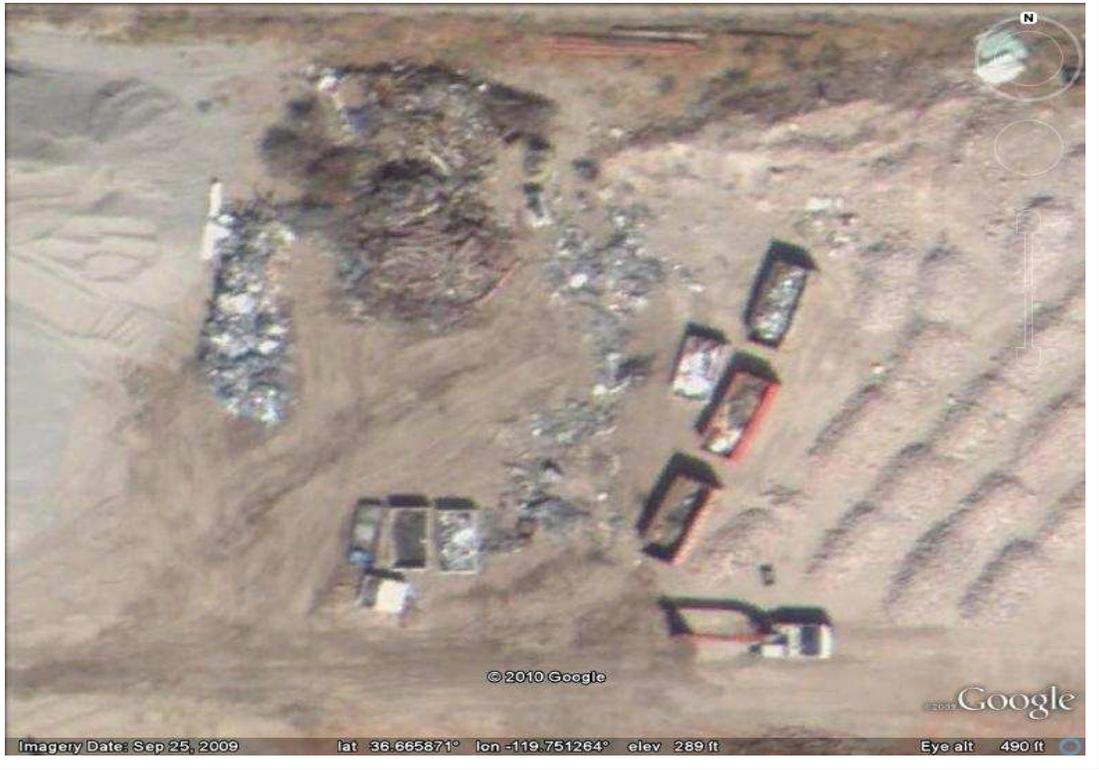
<p>Photo No. 6</p>
<p>Direction Photo Taken: Aerial view; north at the top of frame</p>
<p>Description: Recycled asphalt and bricks at the east end of the site. (CAHST in red)</p>

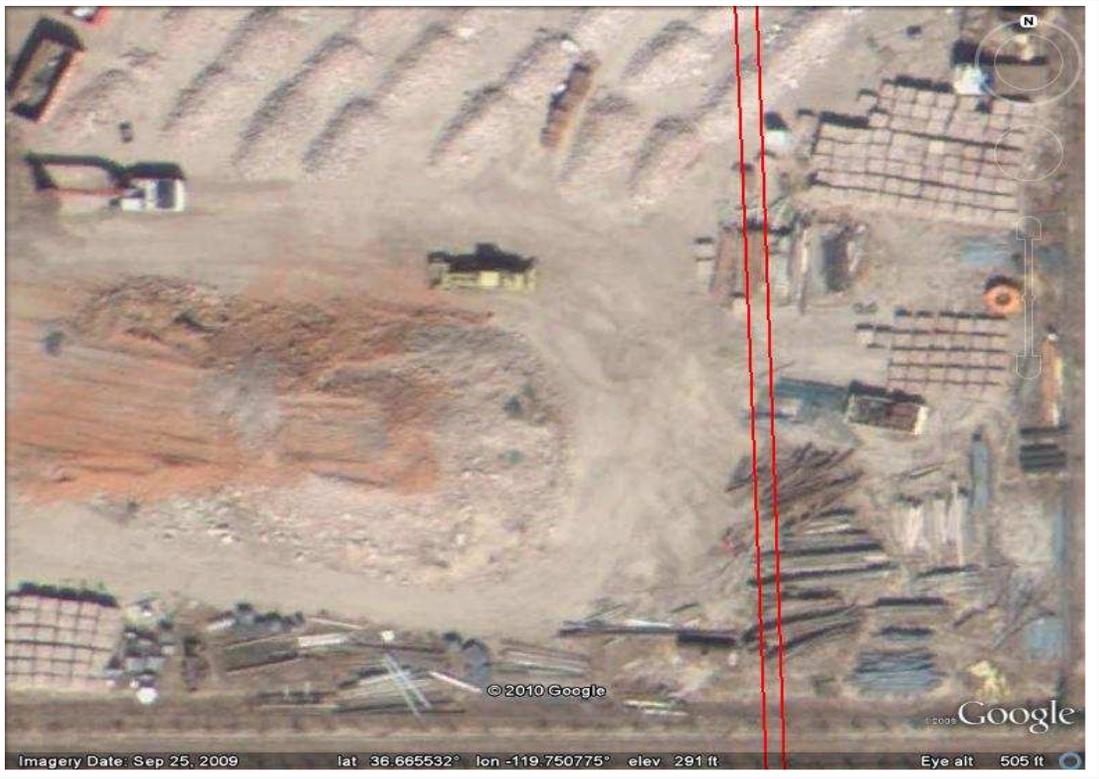
<p>Photo No. 8</p>
<p>Direction Photo Taken: Aerial view; north at the top frame</p>
<p>Description: Stored and recycled materials, used bricks, and scrap metal located near the center of the site.</p>

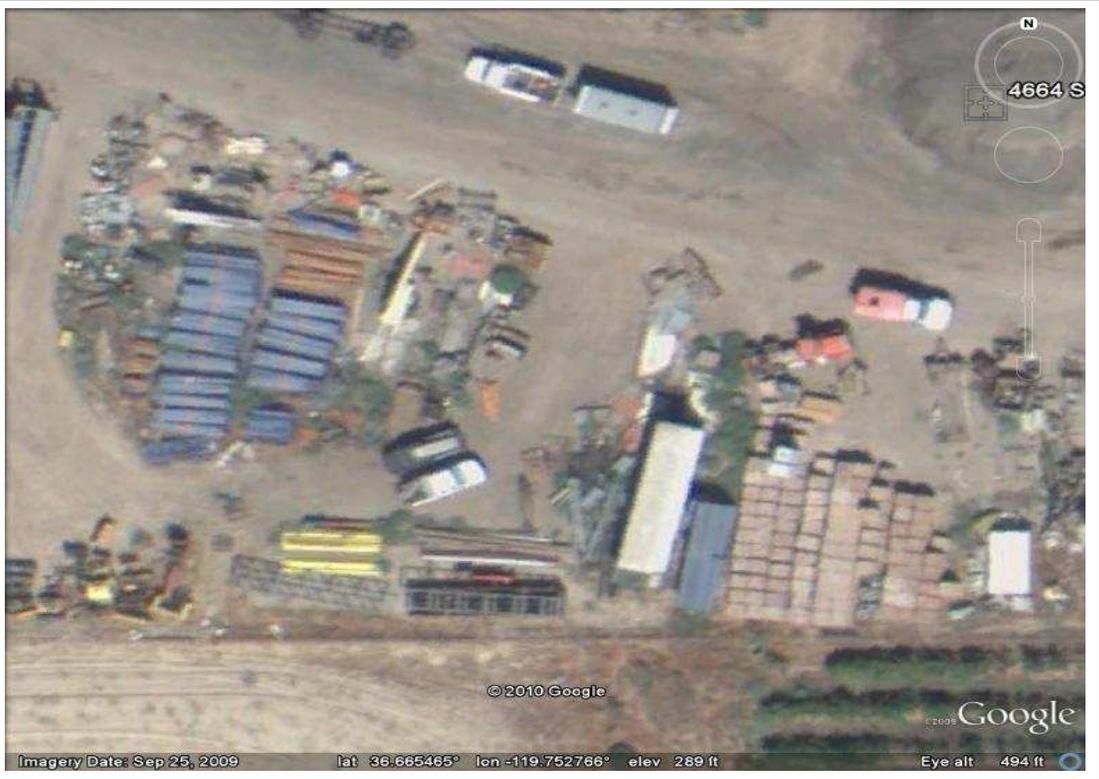
<p>Photo No. 9</p>	
<p>Direction Photo Taken: Aerial view; north at the top of frame</p>	
<p>Description: Stormwater retention basin located on the south side of the site, southeast of the shop. A storm drain was observed near the center of the site and it appears that all stormwater from the site discharges to the basin.</p>

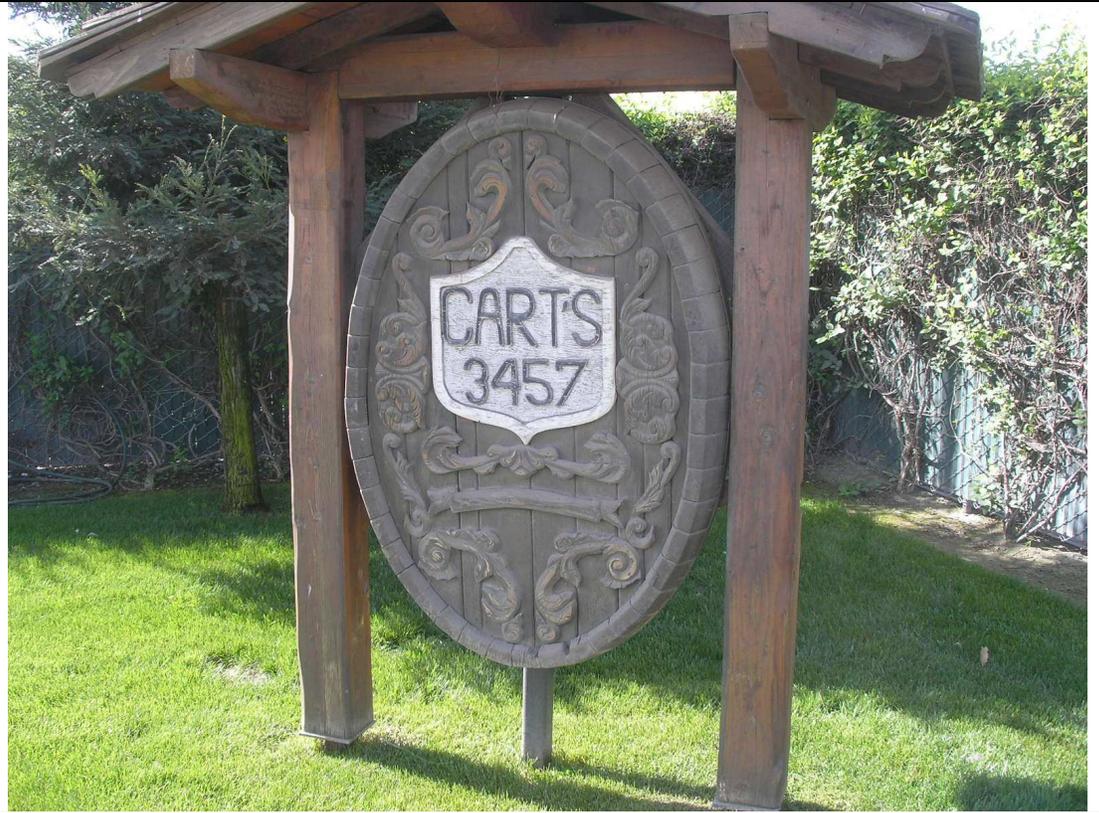
<p>Photo No. 2</p>	
<p>Direction Photo Taken: Looking west</p>	
<p>Description: Site entrance, office, scale house, scales, former Orange Avenue Landfill, closed in 2007, is visible in the background.</p>

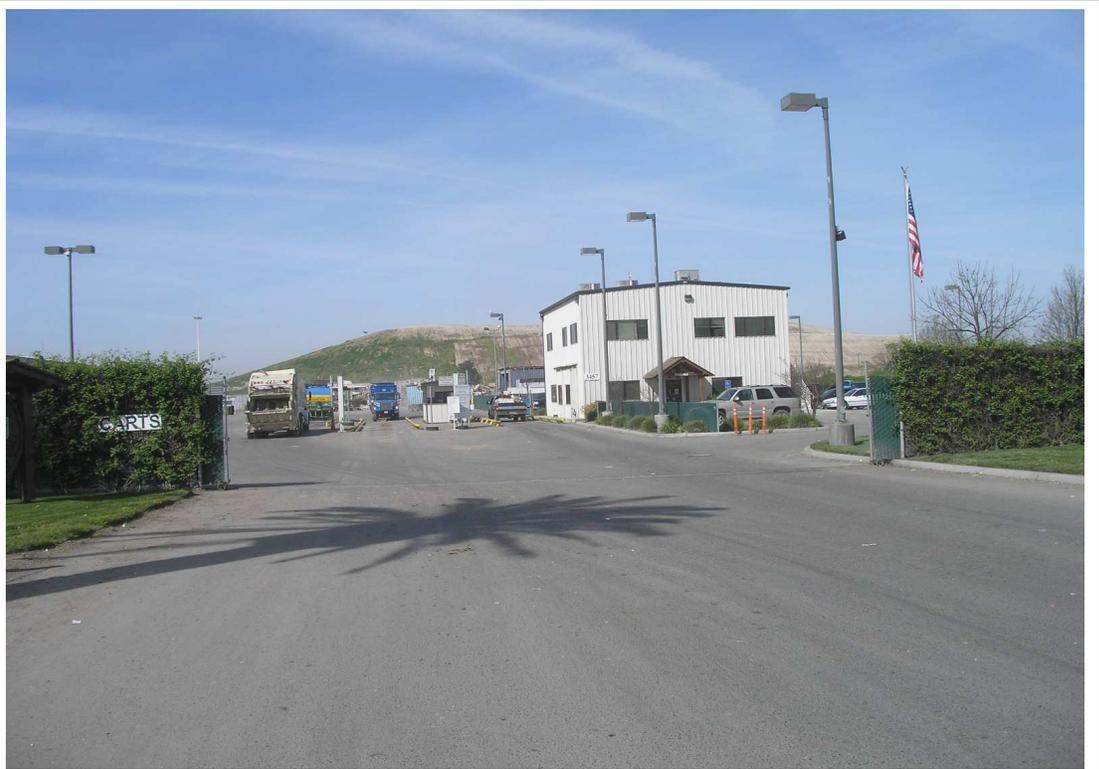
<p>Photo No. 3</p>

<p>Direction Photo Taken: Looking northwest</p>	
<p>Description: Office, scale house, and scales.</p>

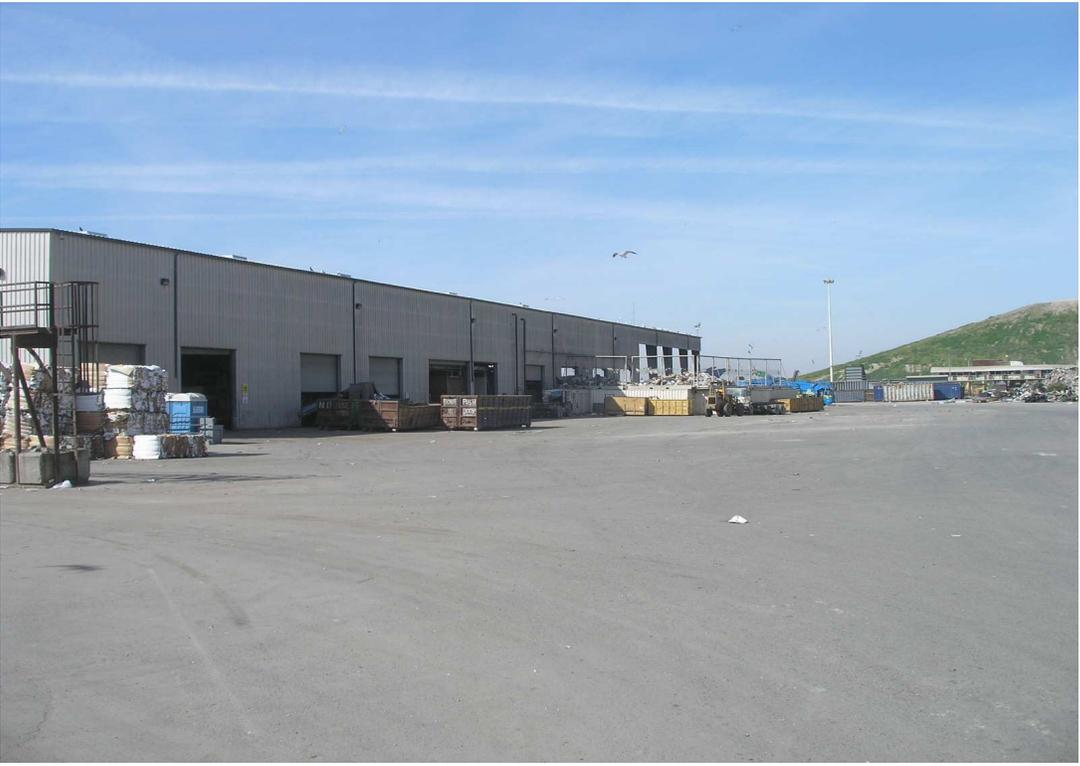
<p>Photo No. 4</p>

<p>Direction Photo Taken: Looking southwest</p>	
<p>Description: Sorting building and recycle center.</p>

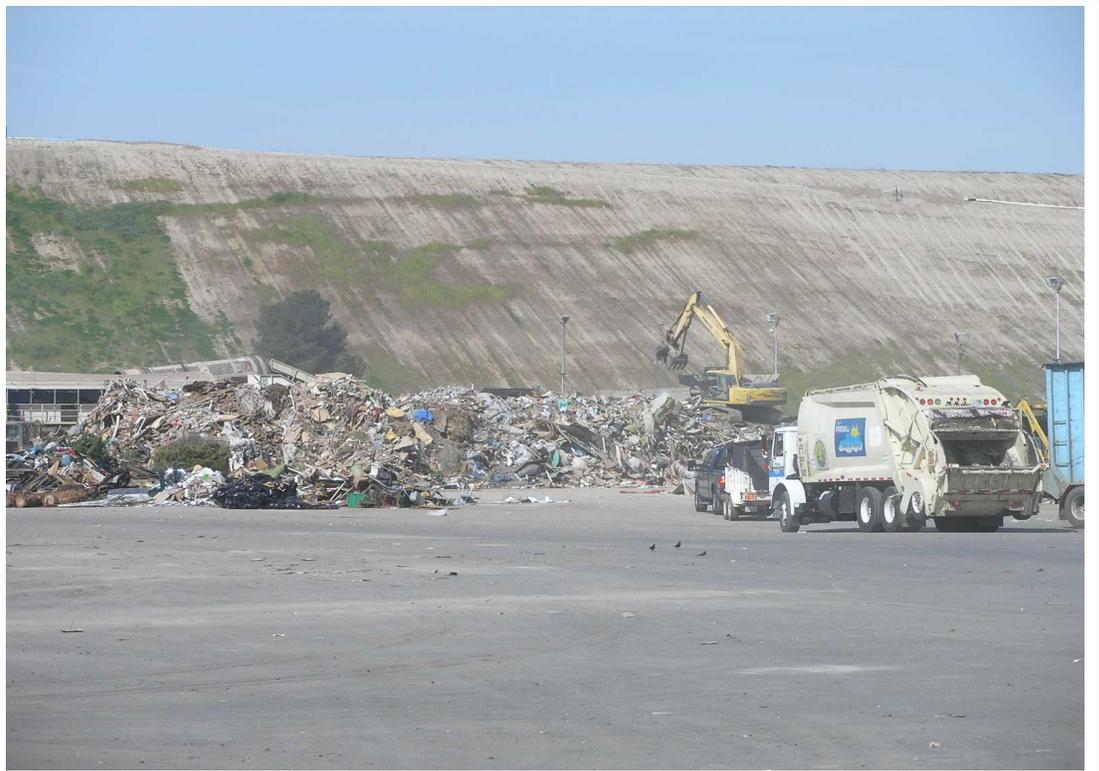
<p>Photo No. 8</p>
<p>Direction Photo Taken: Looking north</p>
<p>Description: CARTS also operates a concrete and asphalt recycling facility on the site adjacent to the transfer station and recycling center.</p>

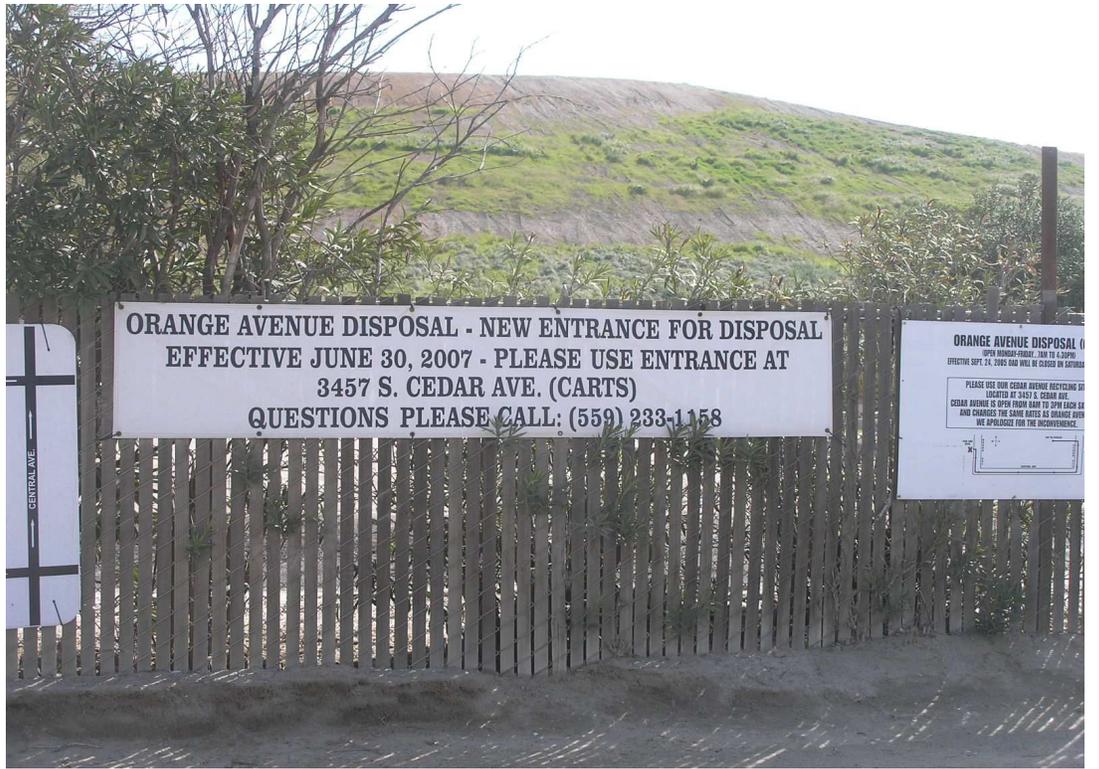
<p>Photo No. 12</p>
<p>Direction Photo Taken: Looking northeast</p>
<p>Description: Former Orange Avenue Landfill site shipping and receiving area. Note ASTs. Site reportedly had leaking USTs and other groundwater contamination issues.</p>

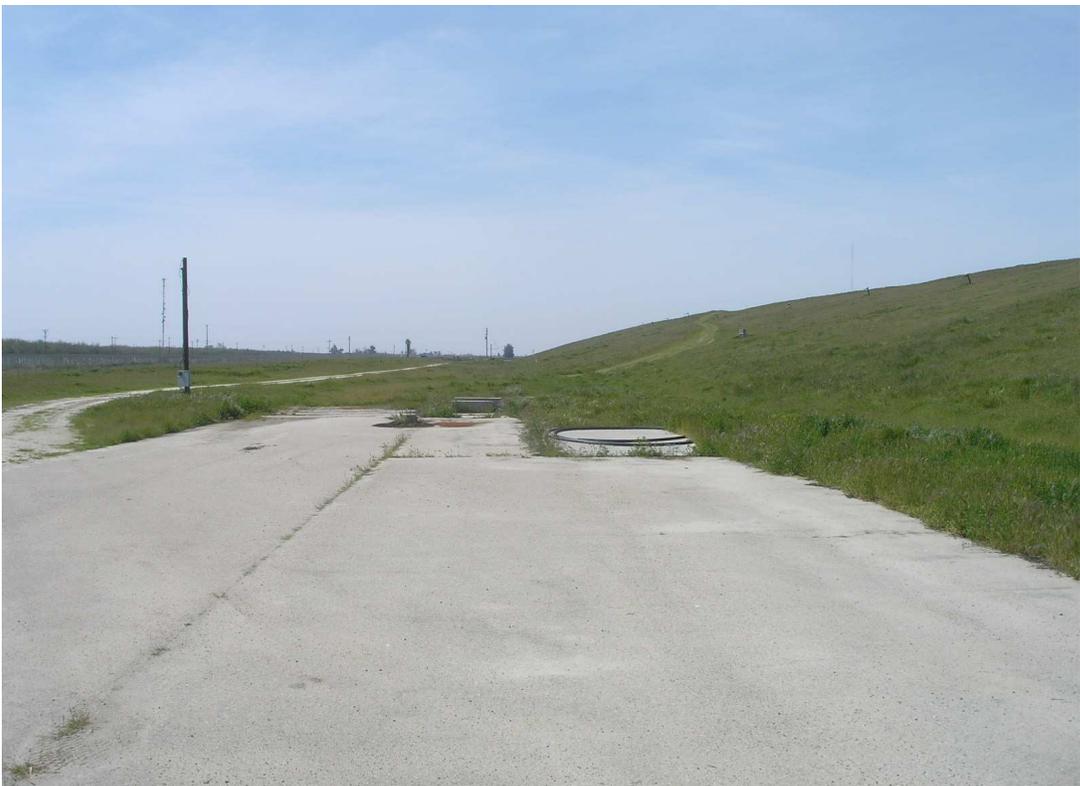
<p>Photo No. 1</p>

<p>Direction Photo Taken: Looking west</p>	
<p>Description: Entrance to the former landfill scale house and office located near the southeast corner of the landfill. View along the south side of the landfill.</p>

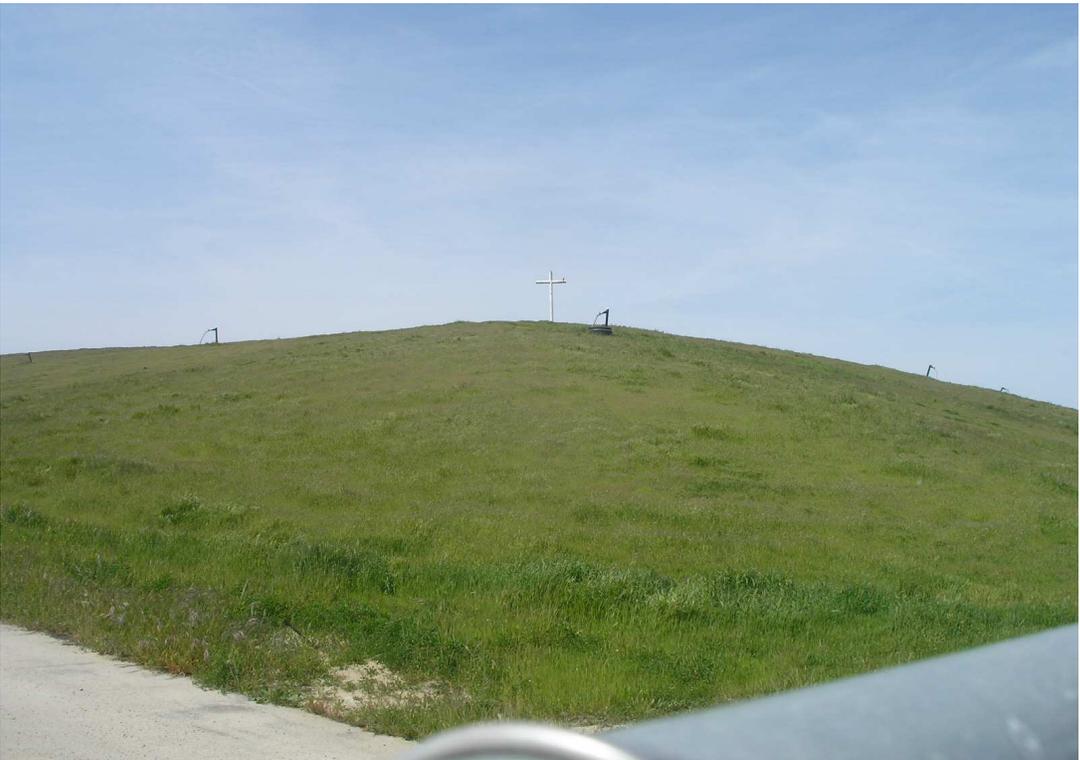
<p>Photo No. 2</p>

<p>Direction Photo Taken: Looking northwest</p>	
<p>Description: Southeast corner of the landfill. Note the soil gas extraction wells on the horizon of the landfill.</p>

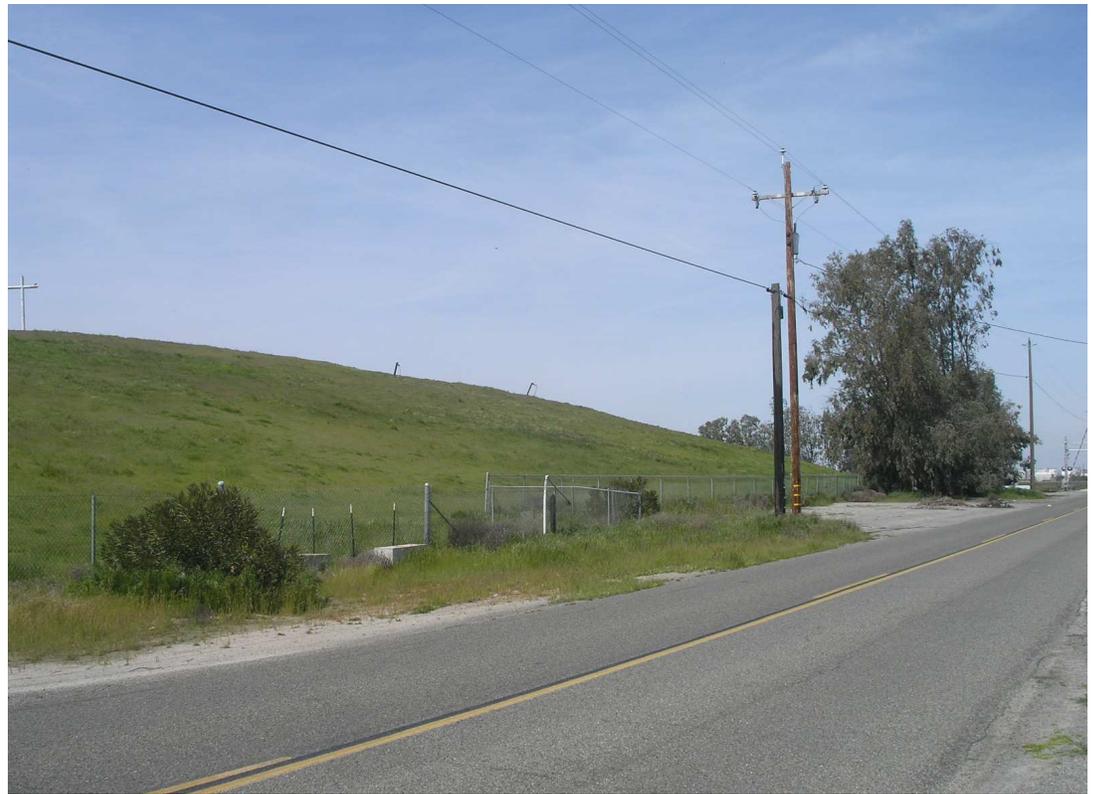
<p>Photo No. 4</p>	
<p>Direction Photo Taken: Looking south</p>	
<p>Description: Looking south along the east end of the site. The BNSF tracks cross Chestnut Avenue near the northeast corner of the landfill. Note the groundwater monitoring well in the lower middle of the frame.</p>

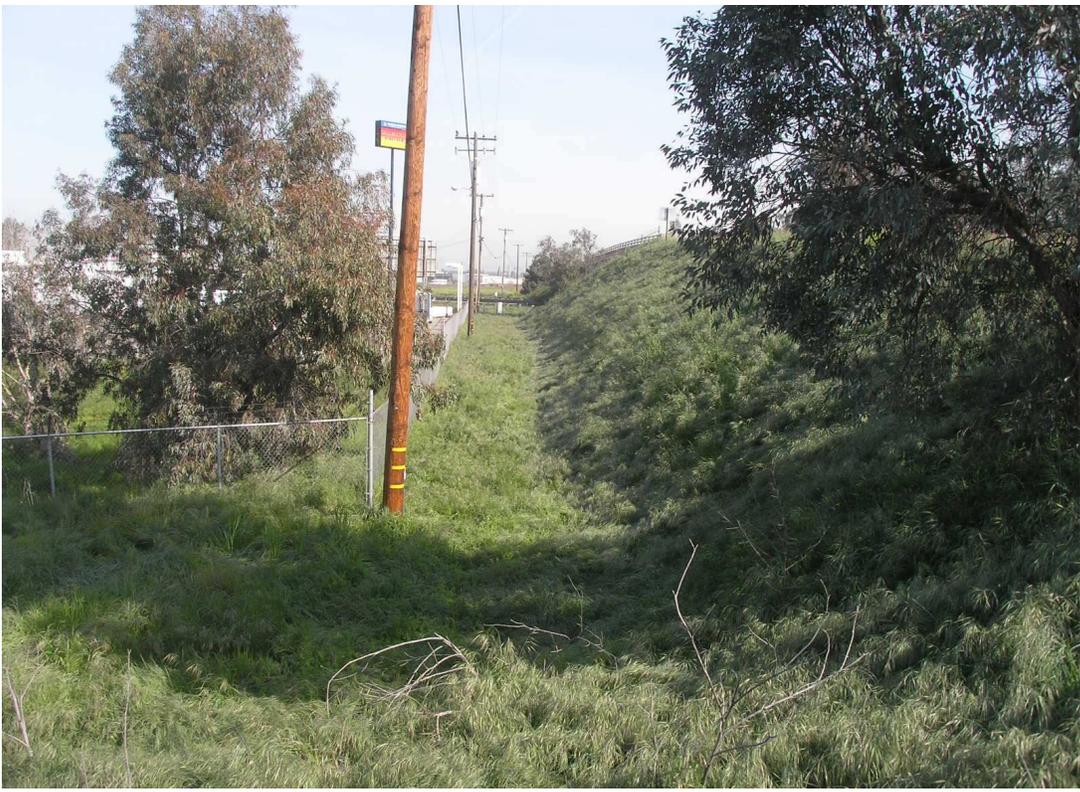
<p>Photo No. 3</p>

<p>Direction Photo Taken: Looking north</p>	
<p>Description: East side of the site. Cedar Avenue overpass over Highway 99 is on the right.</p>

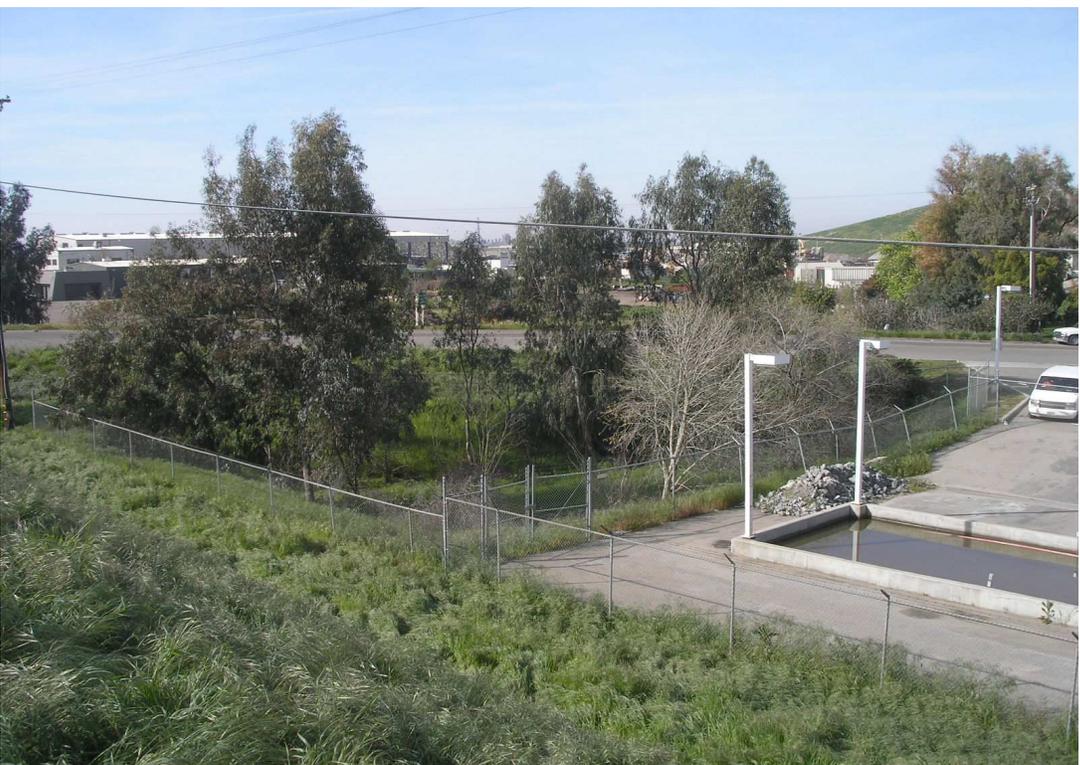
<p>Photo No. 4</p>

<p>Direction Photo Taken: Looking southwest</p>	
<p>Description: Stormwater retention basin at the south end of the site; Parkway Avenue beyond.</p>

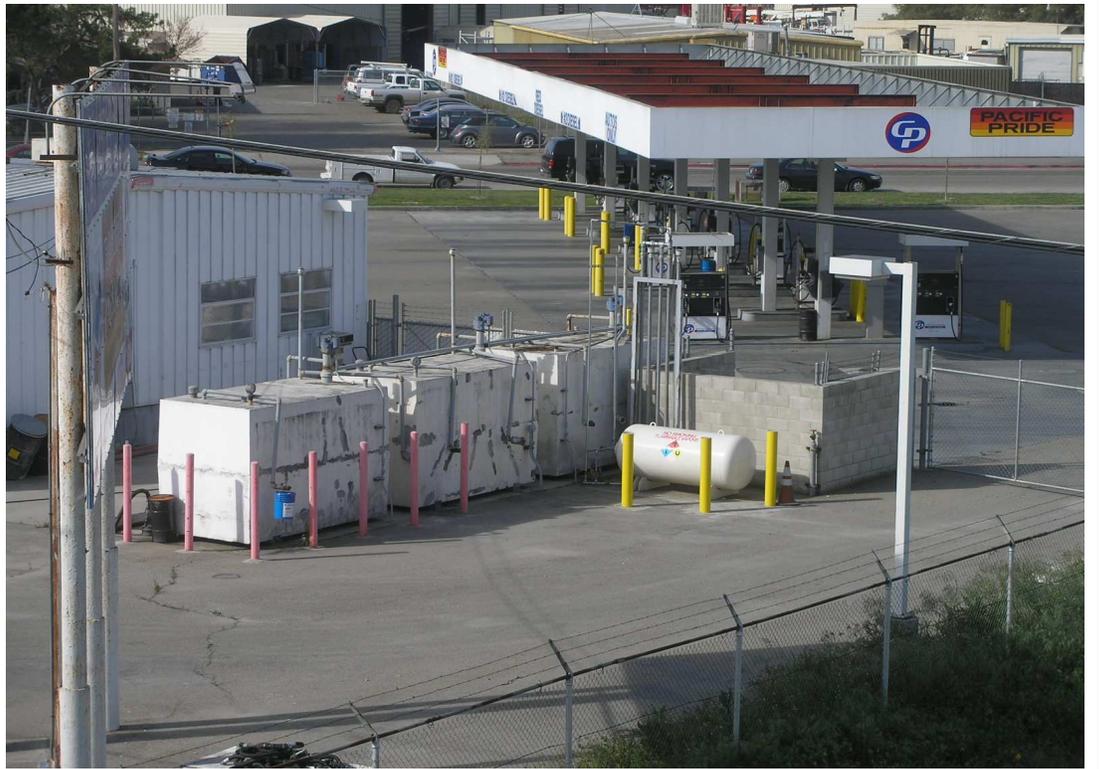
<p>Photo No. 8</p>
<p>Direction Photo Taken: Looking southeast</p>
<p>Description: Five USTs located at the east end of the dispenser islands.</p>

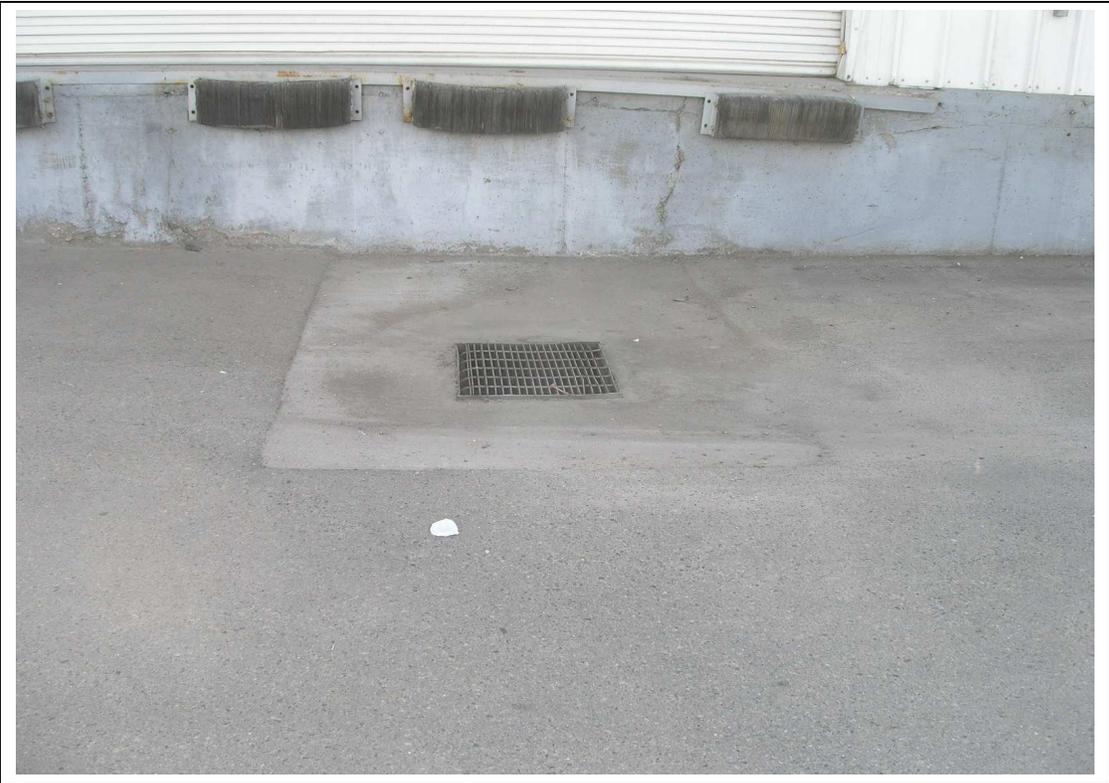
Photo No.
9

Direction Photo Taken:
Looking east

Description:
Stormwater drain on the west side of the office/storage building, near the center of the site. All runoff from the site drains to the retention basin at the south end of the site.

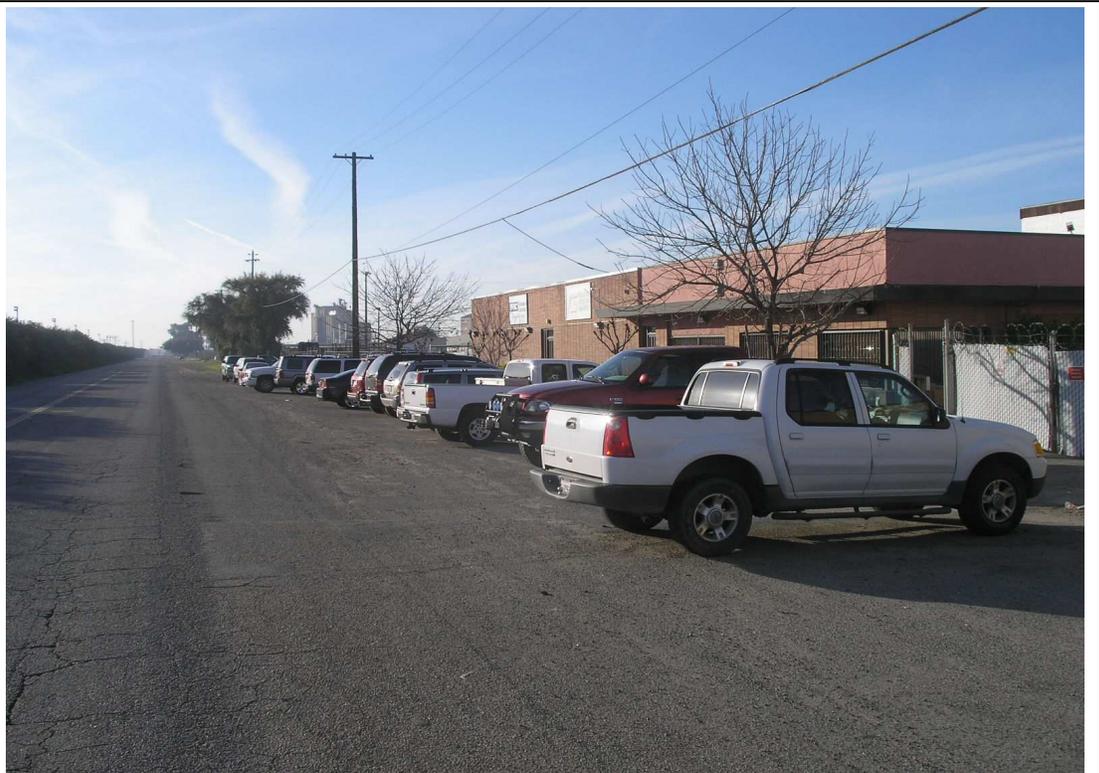
<p>Photo No. 2</p>	
<p>Direction Photo Taken: Looking south</p>	
<p>Description: View of the east side of the PARC facility along Railroad Avenue. The Union Pacific tracks are east of the shrubbery at the left of the frame.</p>

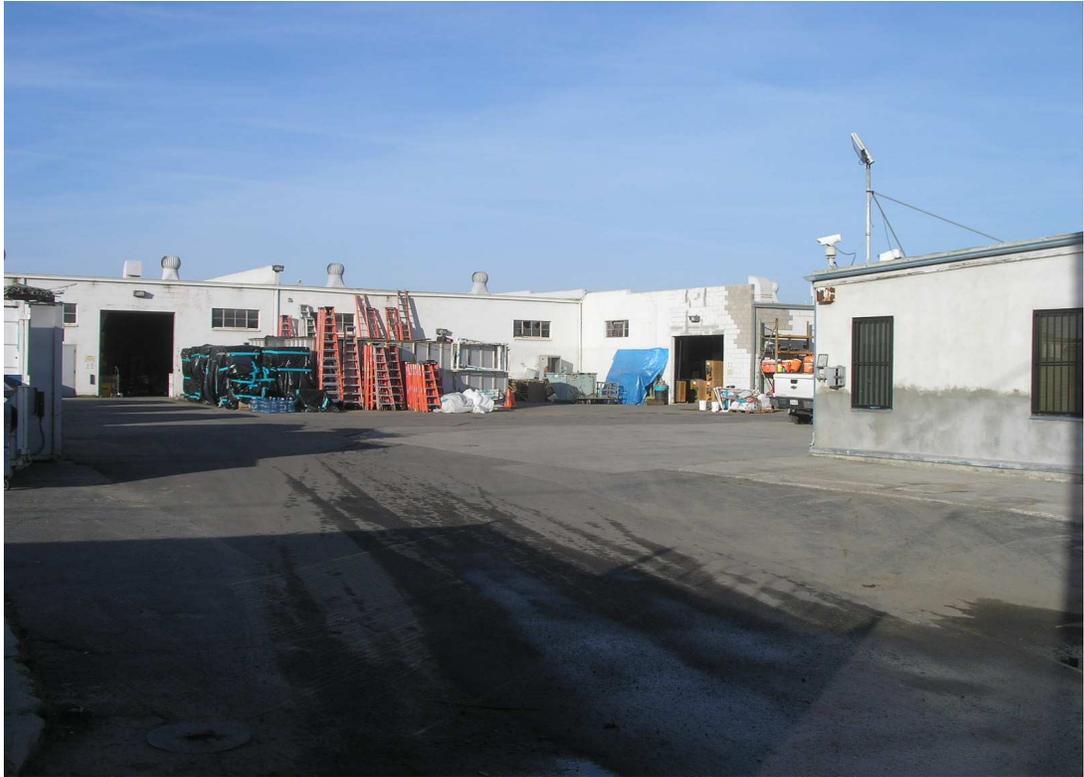
<p>Photo No. 3</p>

<p>Direction Photo Taken: Looking west</p>	
<p>Description: Equipment and materials storage around the warehouse on the north and west sides of the site.</p>

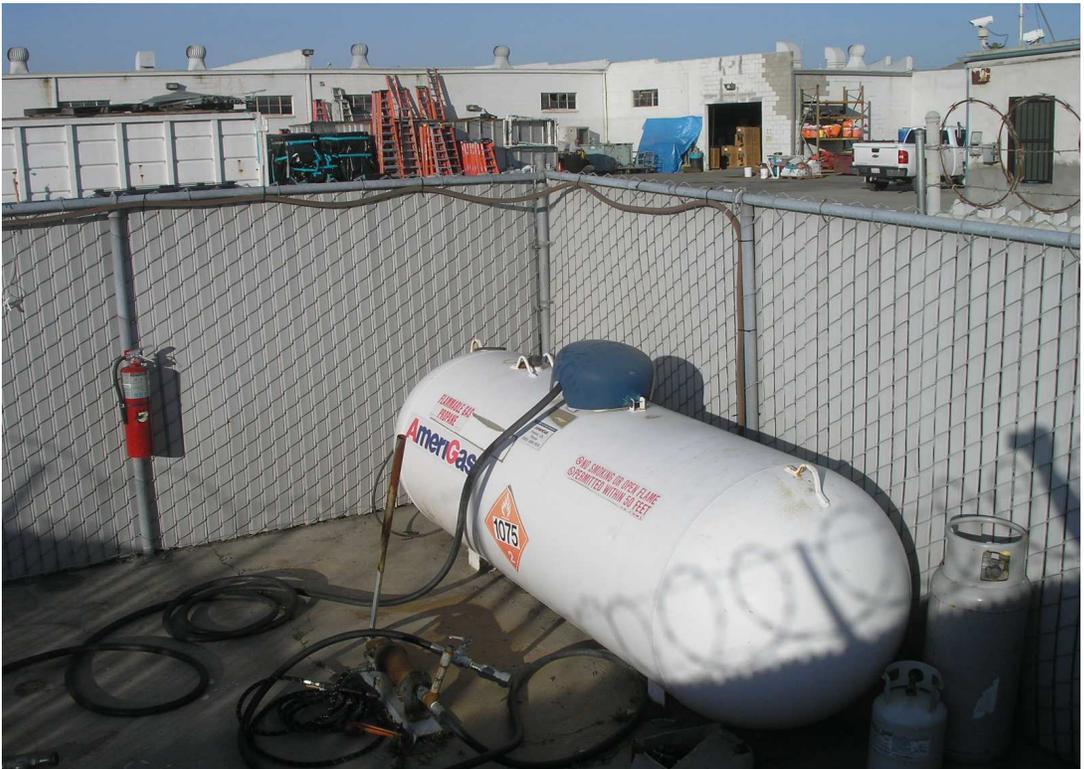
<p>Photo No. 4</p>

<p>Direction Photo Taken: Looking west</p>	
<p>Description: Propane is used for forklift fuel. The tank is located near the main entrance to the site along Railroad Avenue</p>

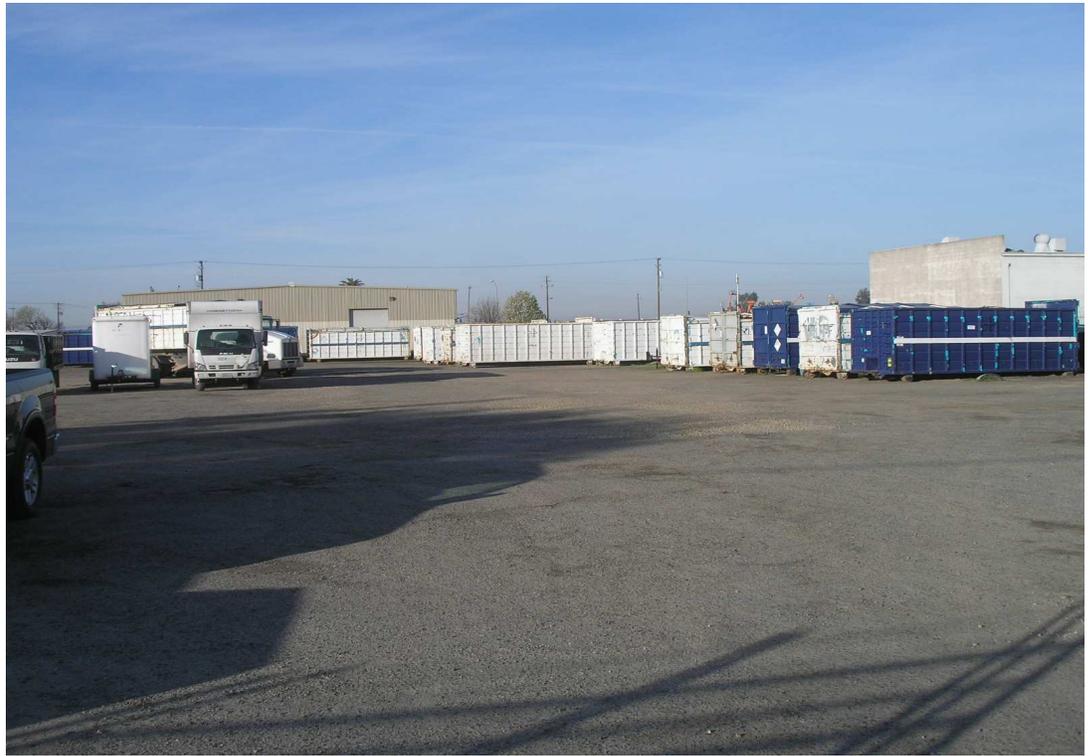
<p>Photo No. 5</p>
<p>Direction Photo Taken: Looking west</p>
<p>Description: Rolloff bins used for environmental cleanup and demolition cleanup work. No asbestos containing materials (ACMs) were observed stored onsite</p>

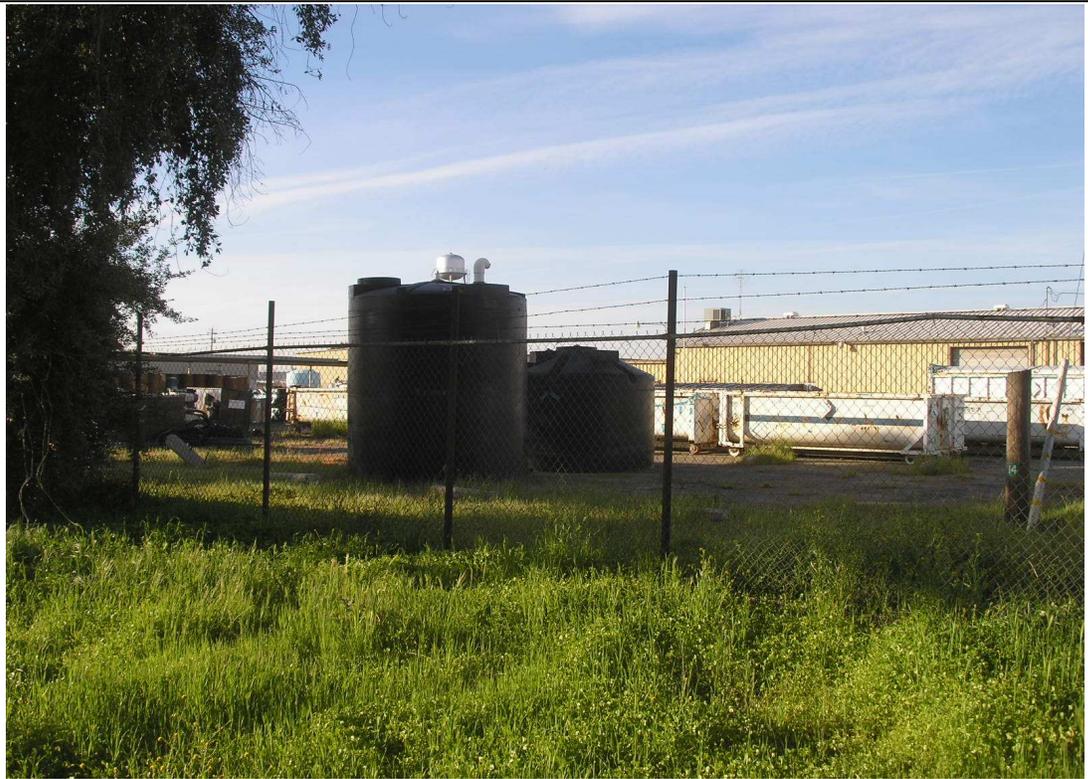
<p>Photo No. 6</p>
<p>Direction Photo Taken: Looking southwest</p>
<p>Description: Empty ASTs and rolloff bins stored near the south end of the site.</p>

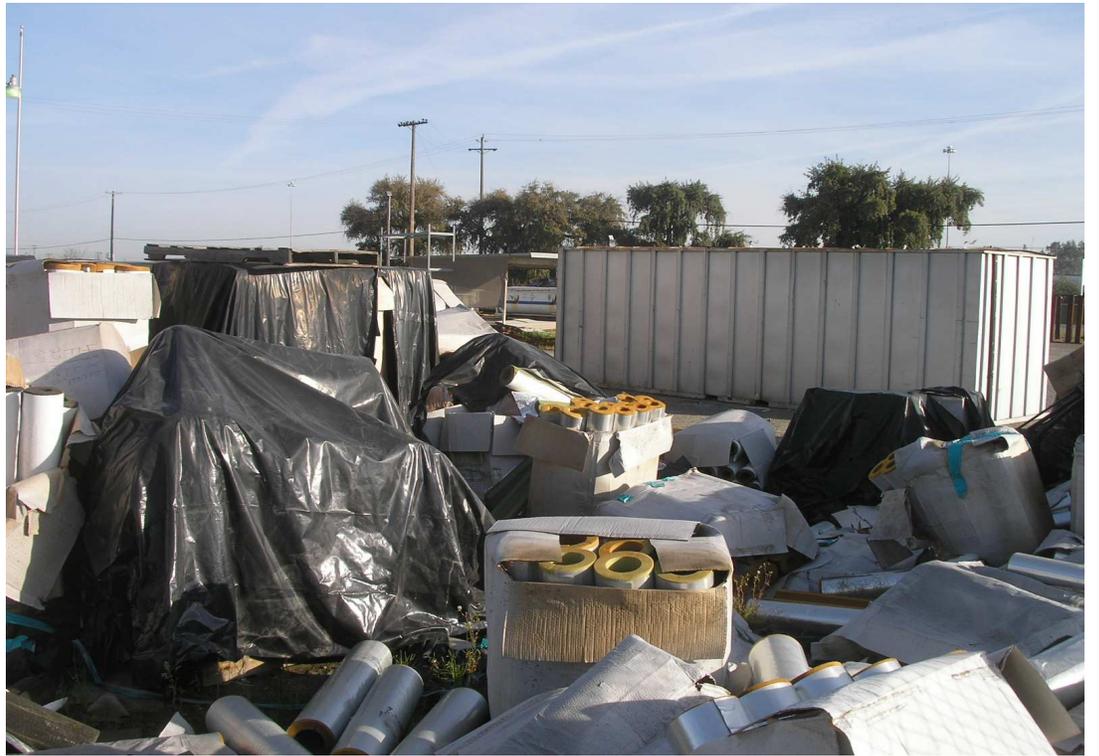
<p>Photo No. 9</p>
<p>Direction Photo Taken: Looking north</p>
<p>Description: Insulation material stored in the south end of the site.</p>

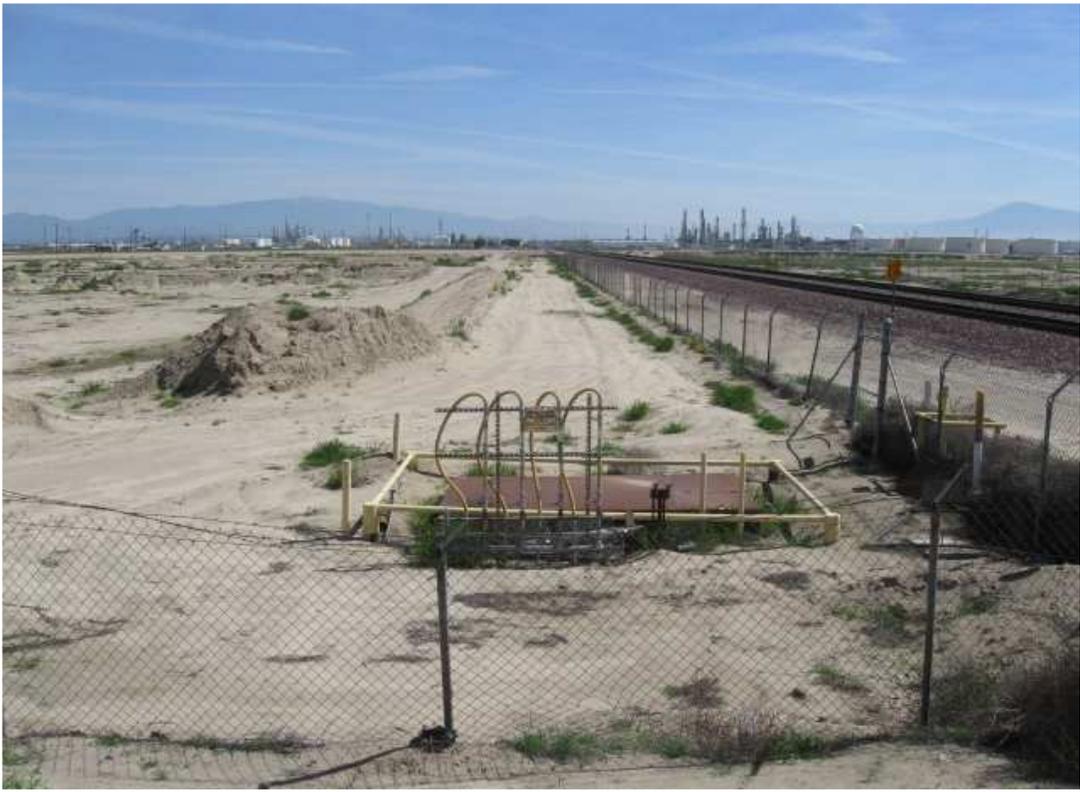
<p>Direction Photo Taken: Looking east</p>	
<p>Description: View of the south end of the site along the BNSF tracks from the southwest corner of the site. Note the soil and groundwater remediation system in the foreground</p>

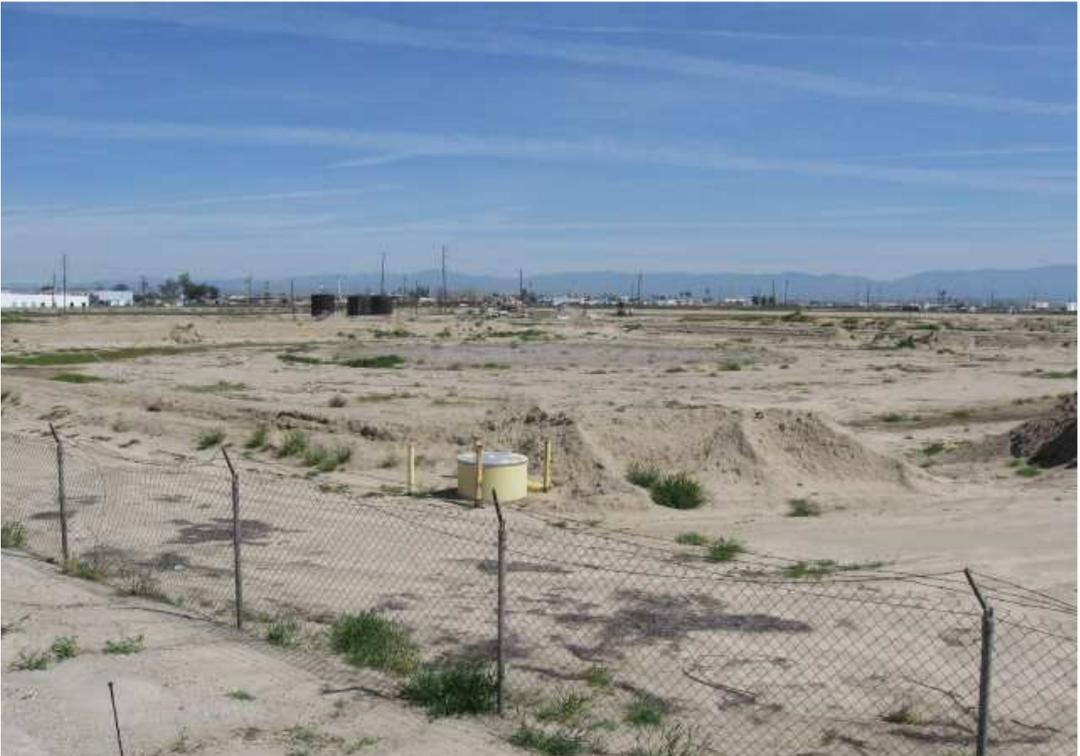
<p>Photo No. 2</p>

<p>Direction Photo Taken: Looking northeast</p>	
<p>Description: View across the site from the southwest corner. Note the remediation well in the lower center of the frame. Also note the former tank pad in the middle of the frame.</p>
