Appendix D

Phase I Site Reconnaissance, Field Notes, Photographs, and Photo Logs Part 2

<p>California High Speed Train</p>	<p>Fresno to Bakersfield Baseline Conditions Report Bowen Engineering & Environmental 4664 S Cedar, Fresno, CA 93725</p>	<p>URS Project No. 27560811.53090100 Date: 3-16-10</p>
---	---	--

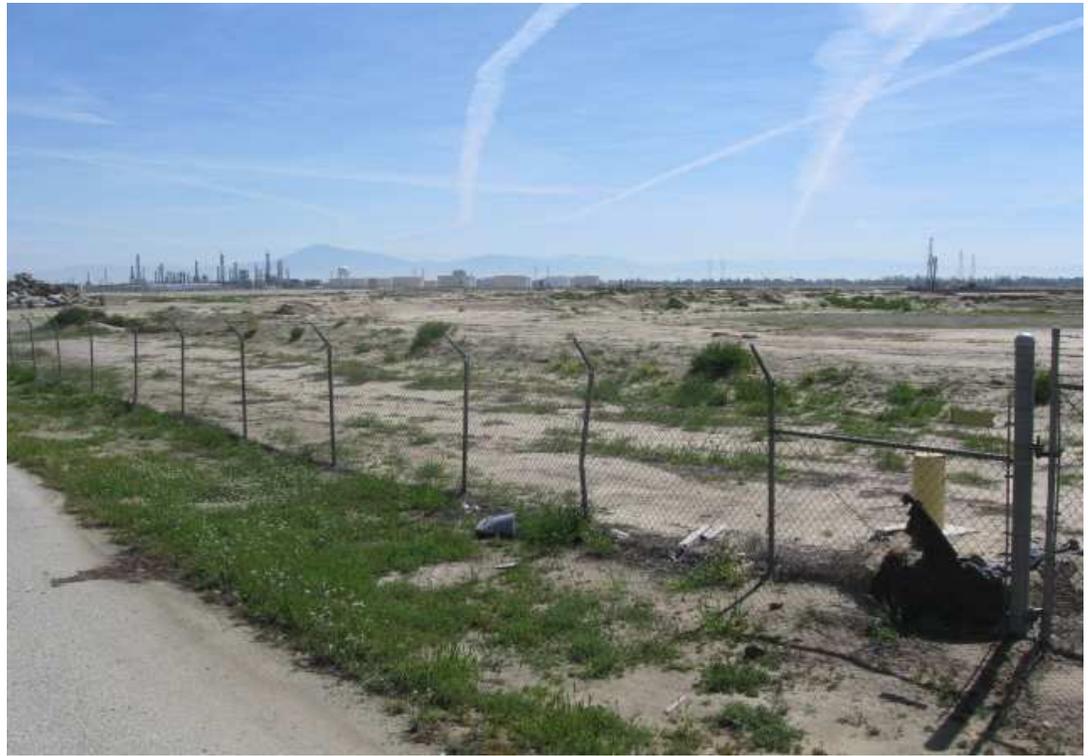
<p>Photo No. 5</p>	
<p>Direction Photo Taken: Looking southeast</p>	
<p>Description: View from the northwest corner of the site. Note the groundwater monitoring well in the lower right corner of the frame.</p>

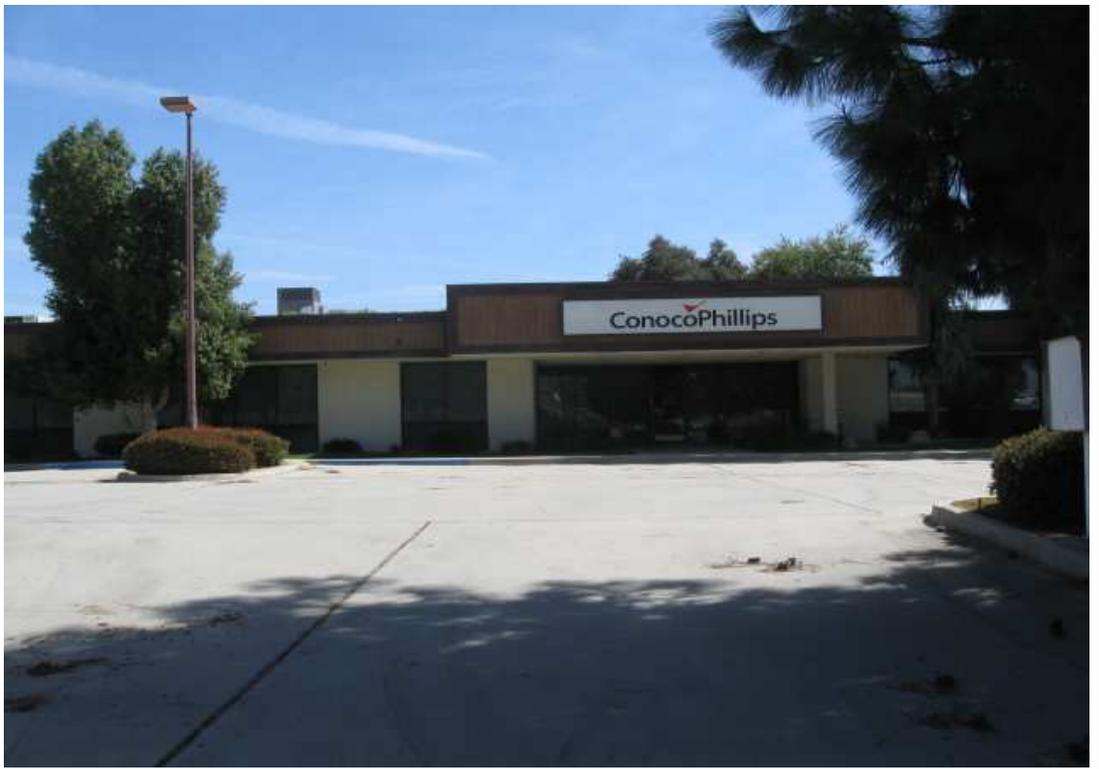
Photo No. 7
Direction Photo Taken: Looking east
Description: Vacant structure at the north end of the site. Reportedly ConocoPhillips had temporarily leased the building and recently moved out.

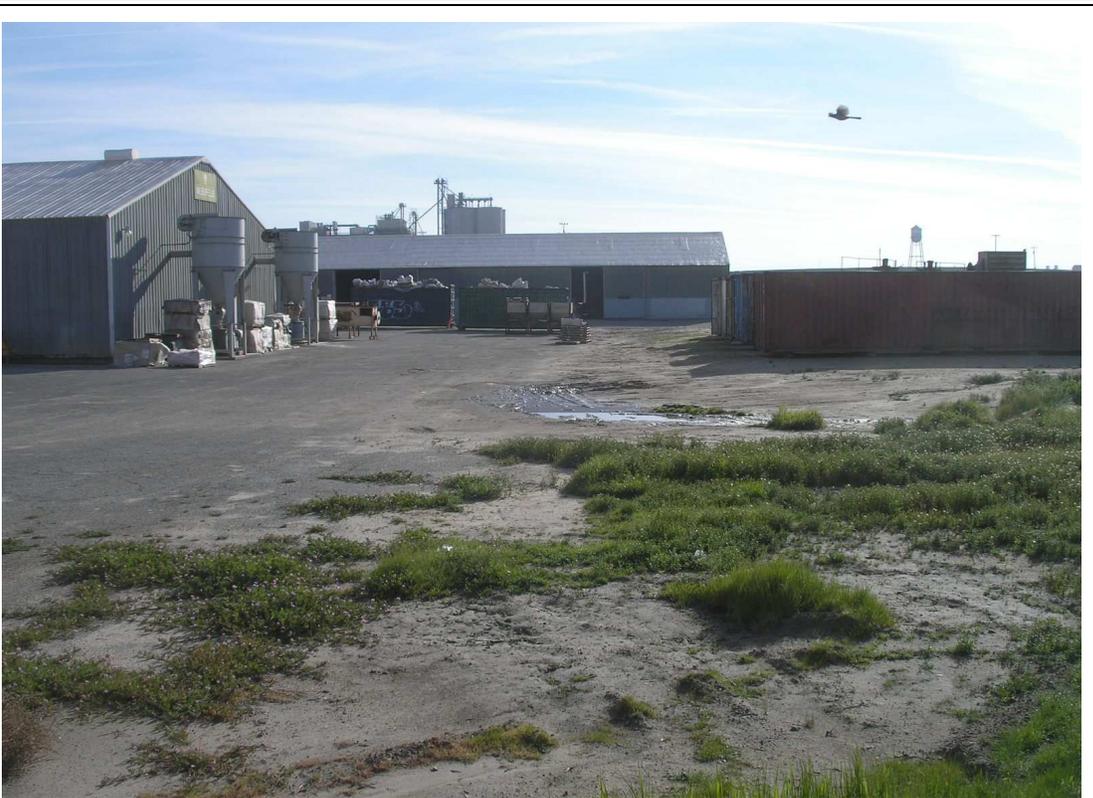
<p>Direction Photo Taken: Looking east</p>	
<p>Description: South end of the warehouse area. Ag chemical storage and preparation for shipping.</p>

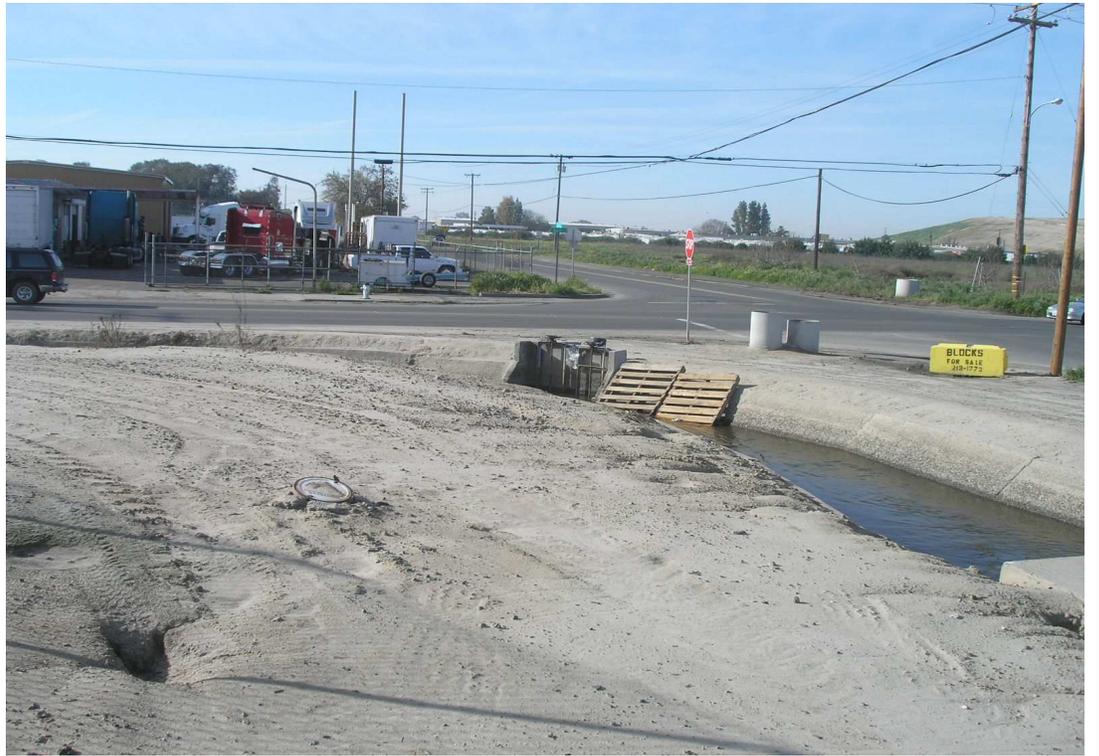
<p>Photo No. 5</p>
<p>Direction Photo Taken: Looking south</p>
<p>Description: Corner of Cedar and North Avenues and the Fresno Colony Canal located at the southwest corner of the site. Note the monitoring well in the left center of the frame.</p>

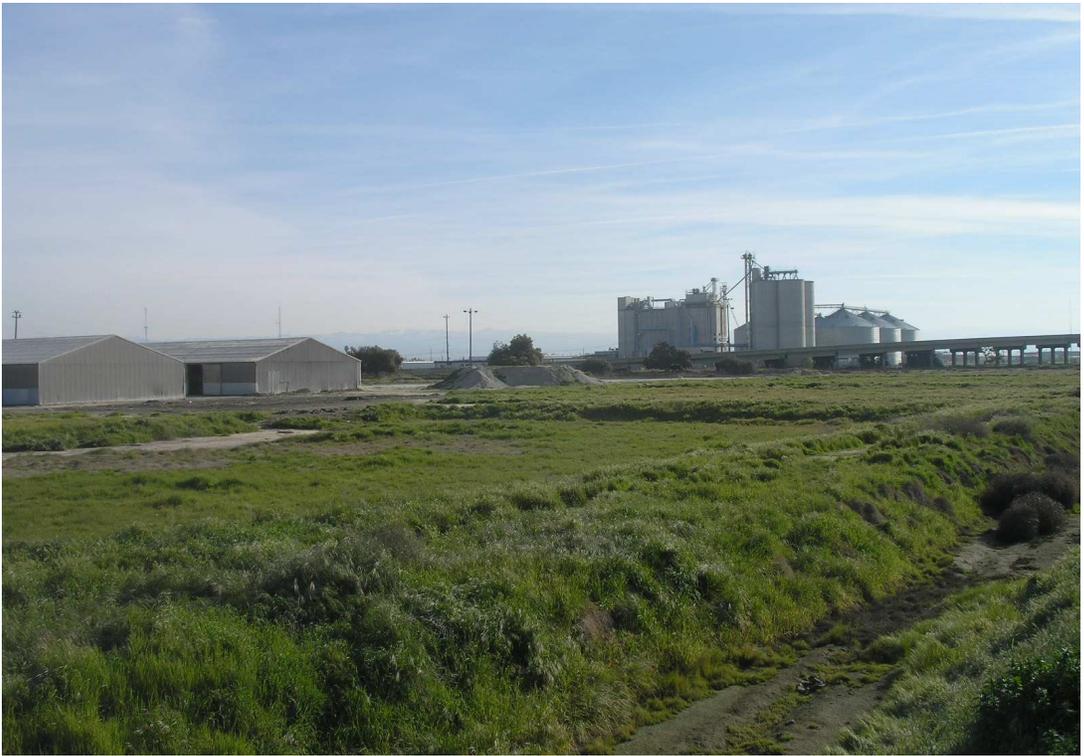
<p>Photo No. 7</p>

<p>Direction Photo Taken: Looking northeast</p>	
<p>Description: Yard drainage area from the southwest corner of the site.</p>

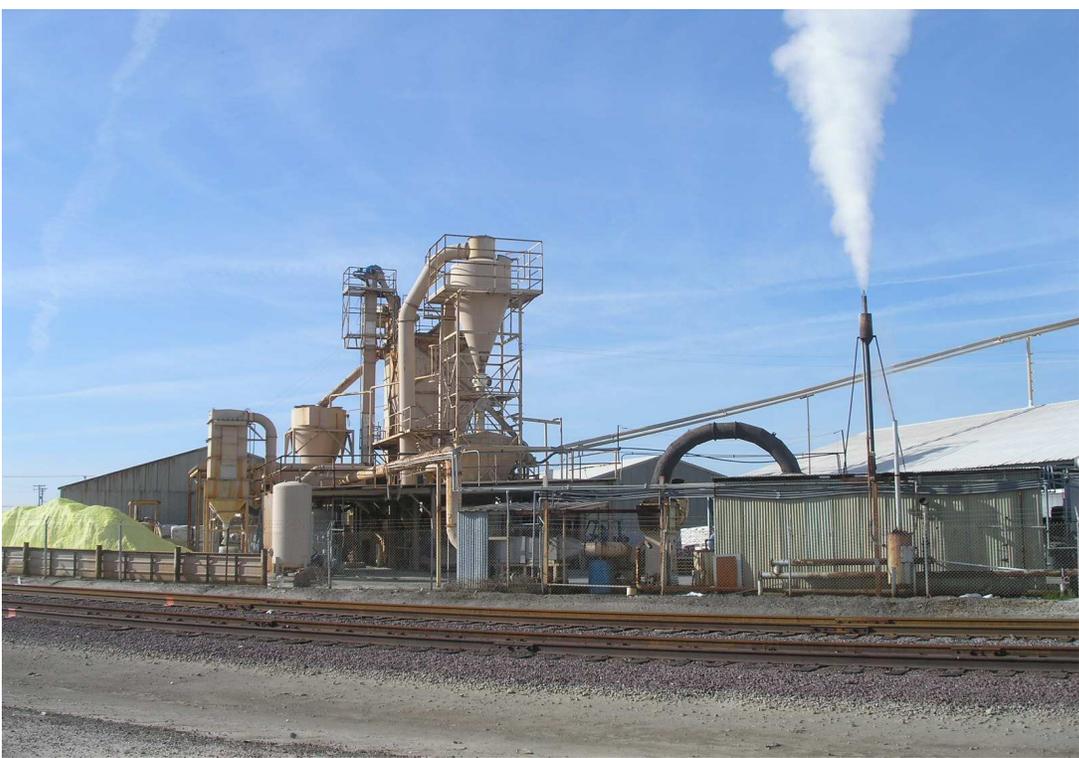
<p>Photo No. 10</p>

<p>Direction Photo Taken: Looking southwest</p>	
<p>Description: View looking across the BNSF rail spurs at "Raymond Mill". Reportedly there is one of two onsite water supply wells and a waste water injection well located in this area.</p>

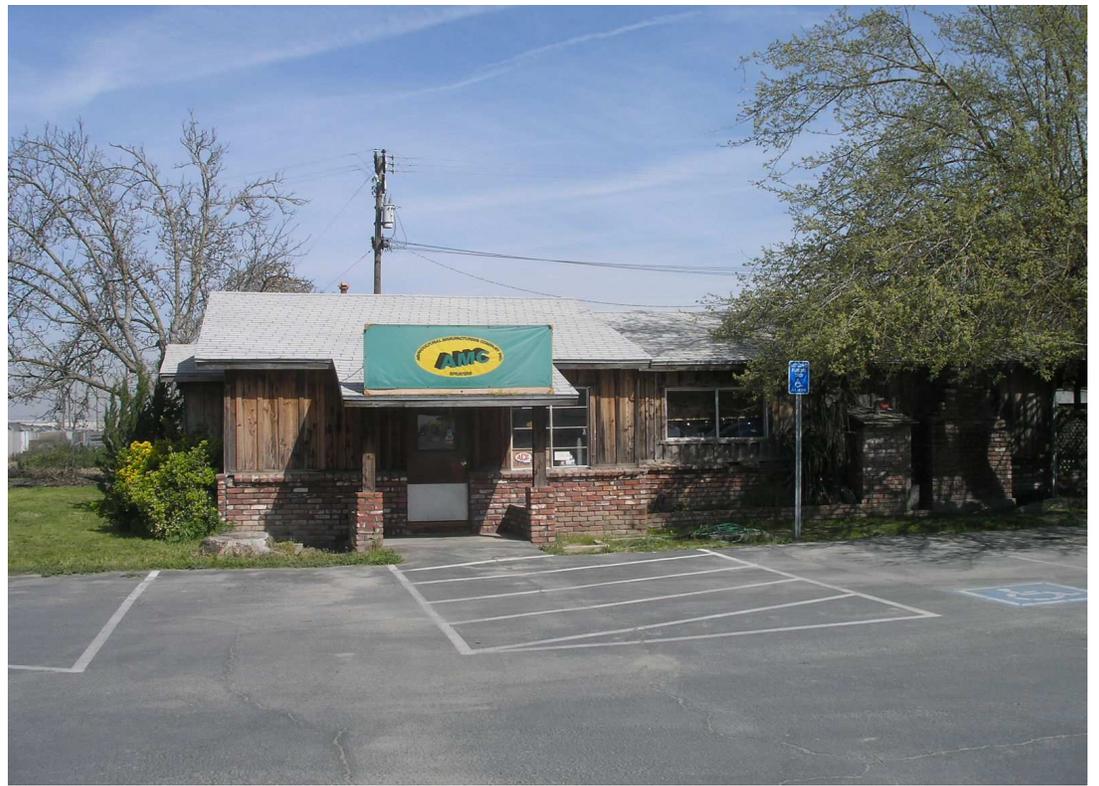
<p>Photo No. 2</p>	
<p>Direction Photo Taken: Looking west</p>	
<p>Description: AMC manufactures agricultural spray equipment like these near the west end of the site. Note Cedar Avenue in the background</p>

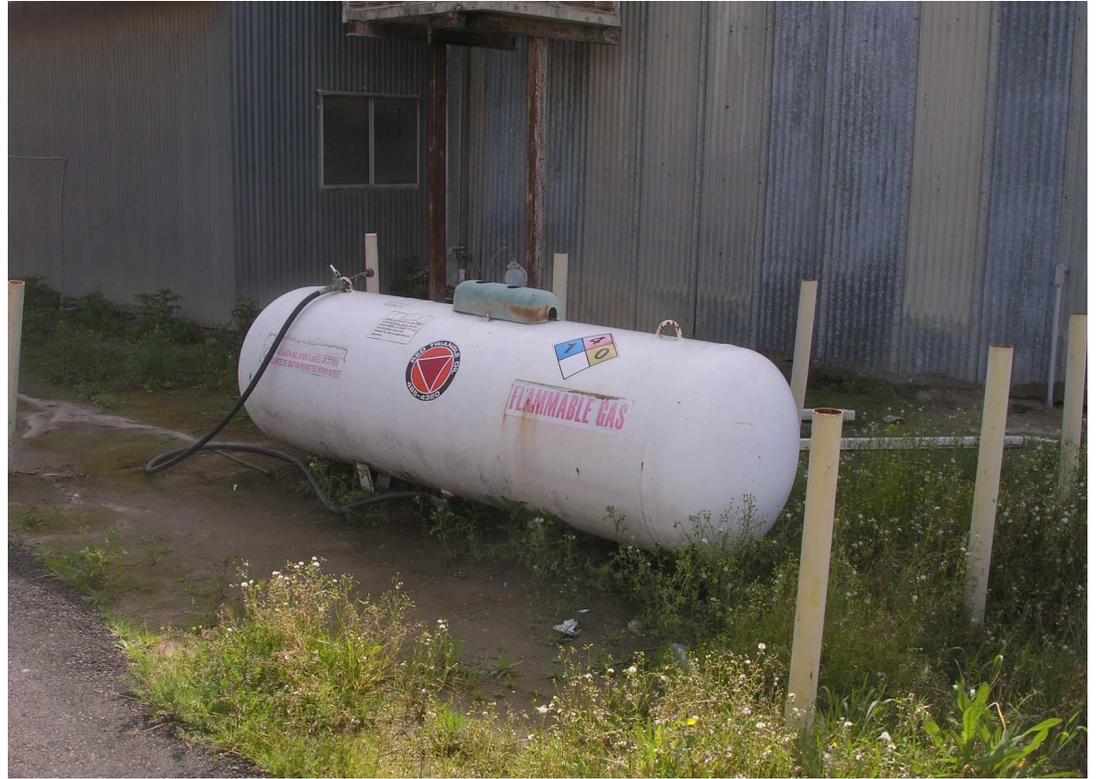
<p>Photo No. 3</p>	
<p>Direction Photo Taken: Looking southeast</p>	
<p>Description: Propane is used to fuel forklifts used onsite.</p>

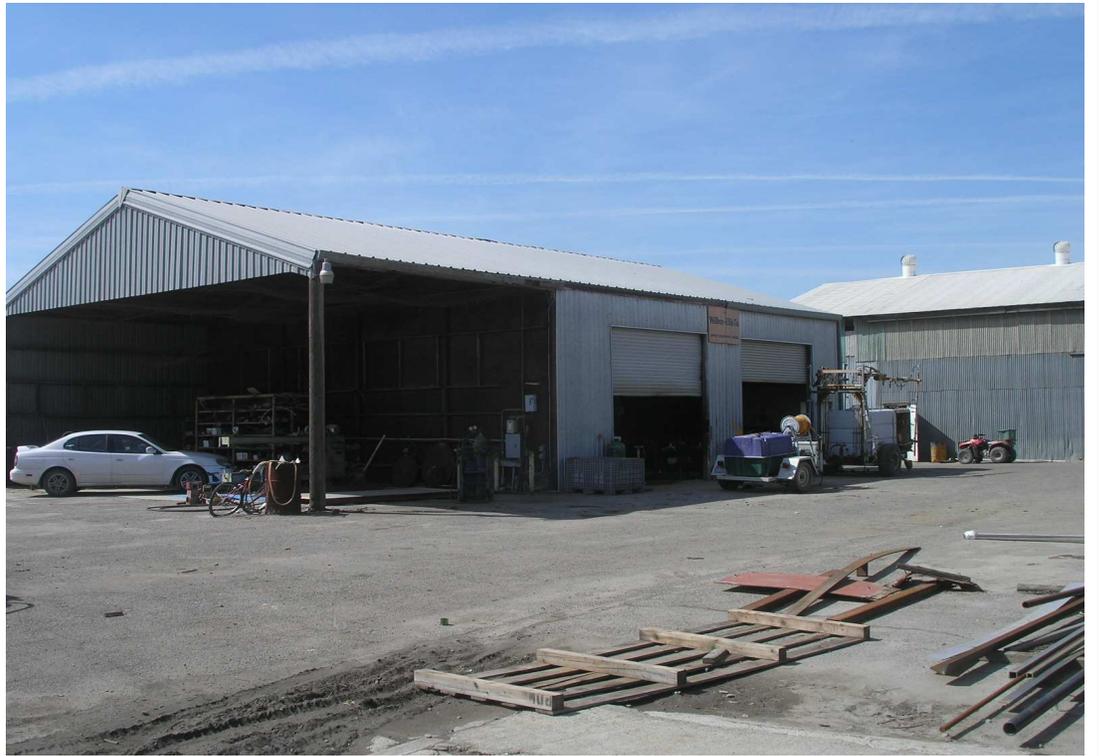
<p>Photo No. 5</p>
<p>Direction Photo Taken: Looking southwest</p>
<p>Description: Machine shop located in the center of the site. This is one of four workshops located onsite.</p>

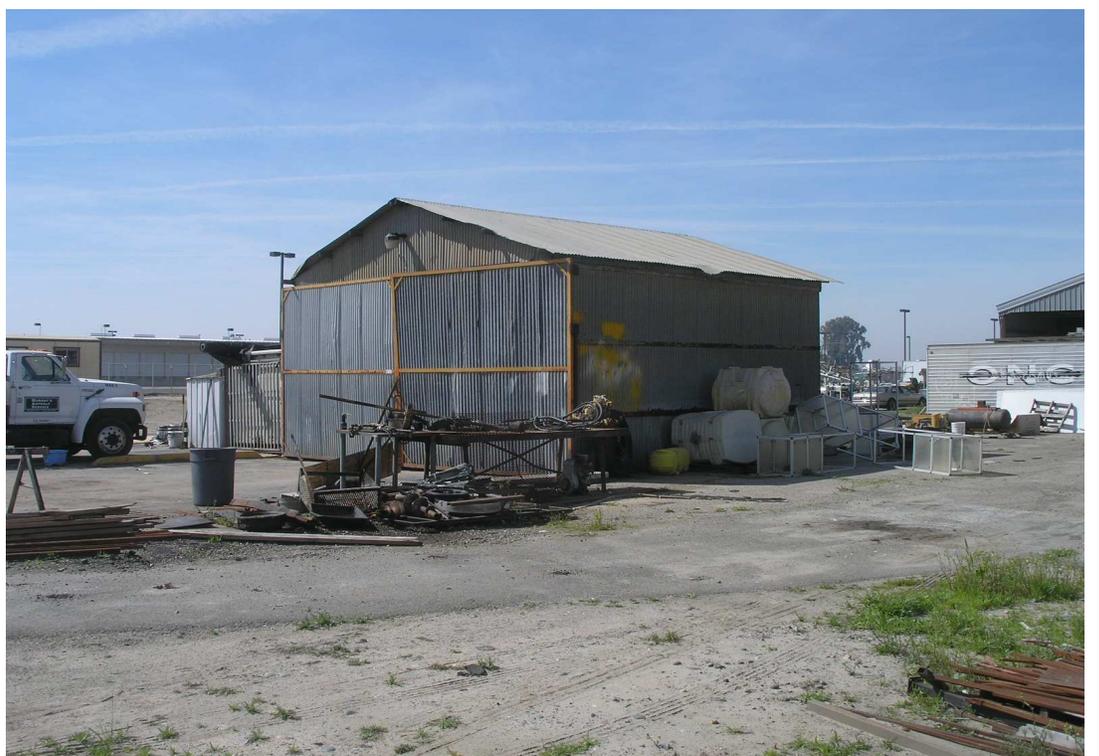
<p>Photo No. 6</p>
<p>Direction Photo Taken: Looking southwest</p>
<p>Description: The site is also occupied by Murray's Asphalt Service. Chemical and paint storage near the middle of the site.</p>

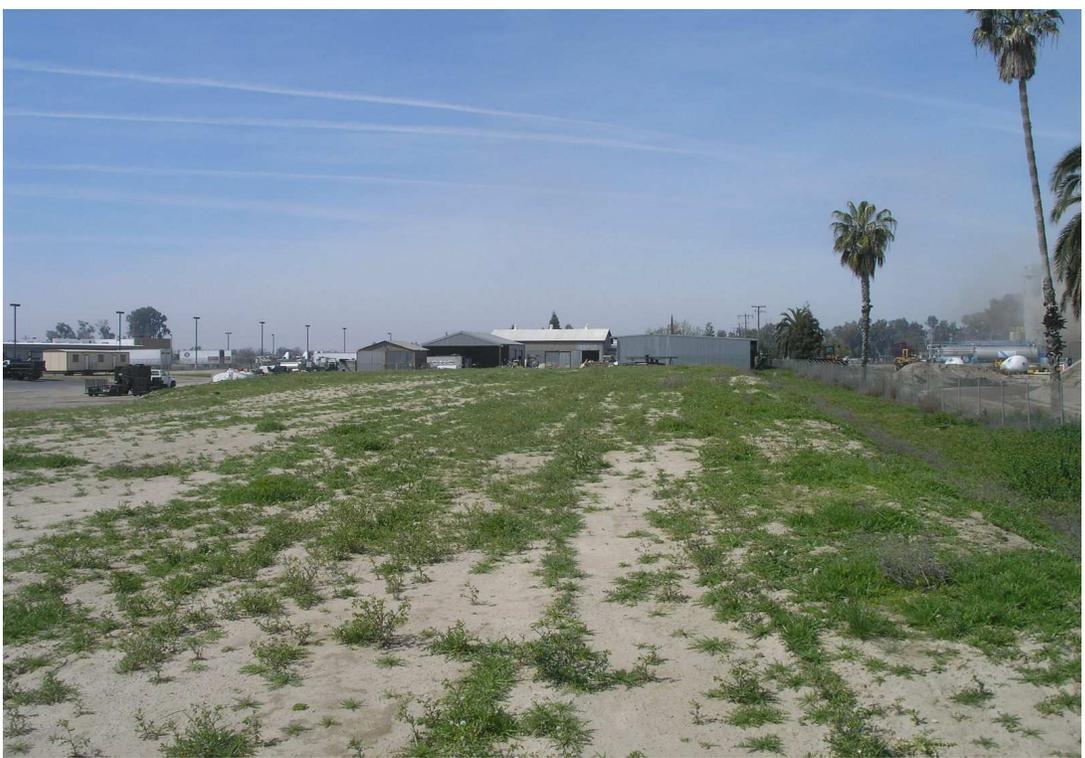
<p>Photo No. 8</p>

<p>Direction Photo Taken: Looking west</p>	
<p>Description: Mounded soil in the northeast corner of the site apparently excavated from the adjacent low spot.</p>

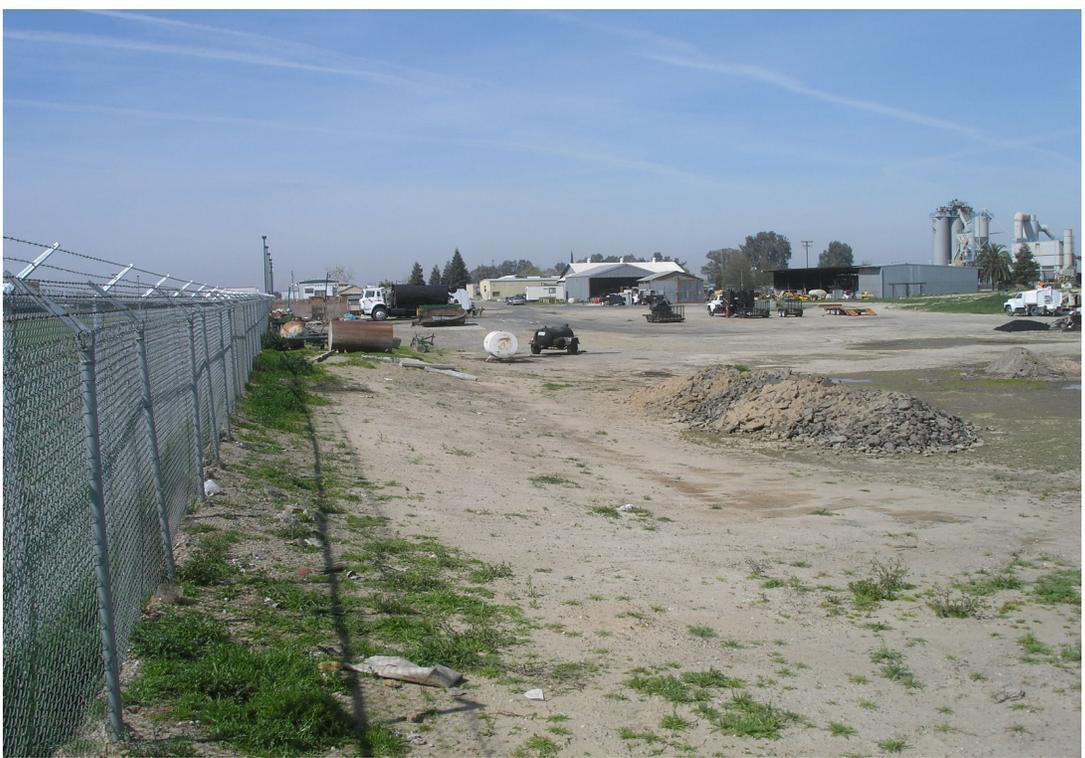
<p>Photo No. 10</p>

<p>Direction Photo Taken: Looking west</p>	
<p>Description: View from the southeast corner of the site. Note the piles of asphalt debris in the low spot.</p>

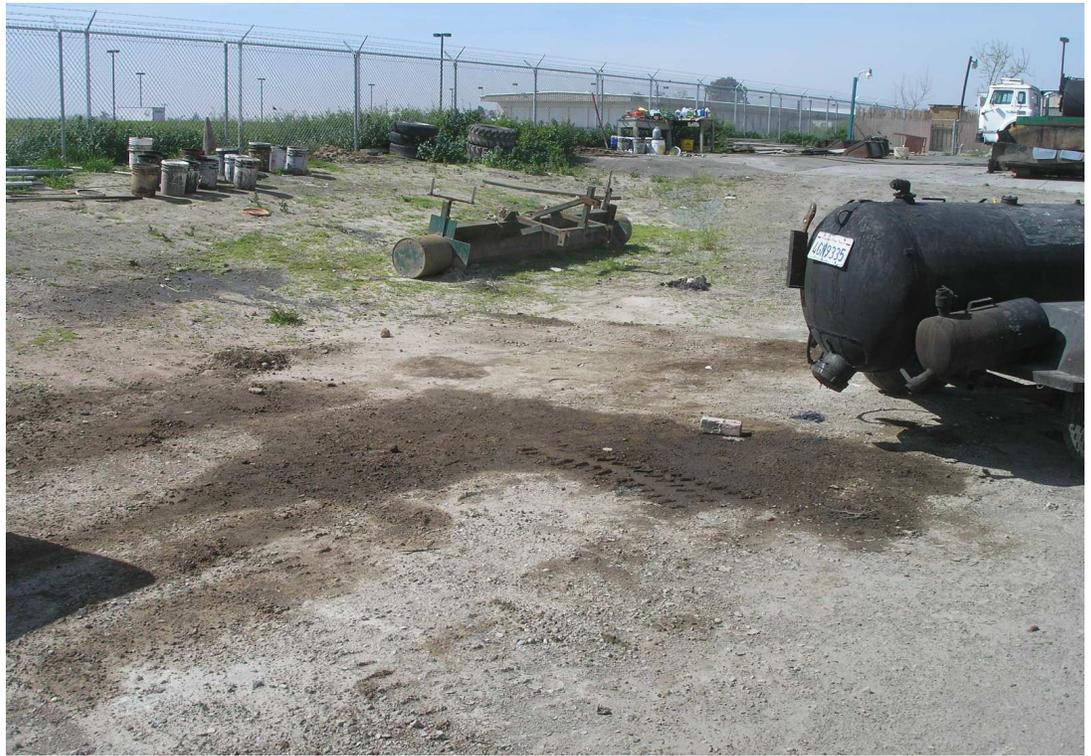
<p>Photo No. 11</p>
<p>Direction Photo Taken: Looking southwest</p>
<p>Description: Oil-stained soil near some of the Murray's Asphalt Service equipment along the south fence. Note the 5-gallon buckets of oil near the fence.</p>

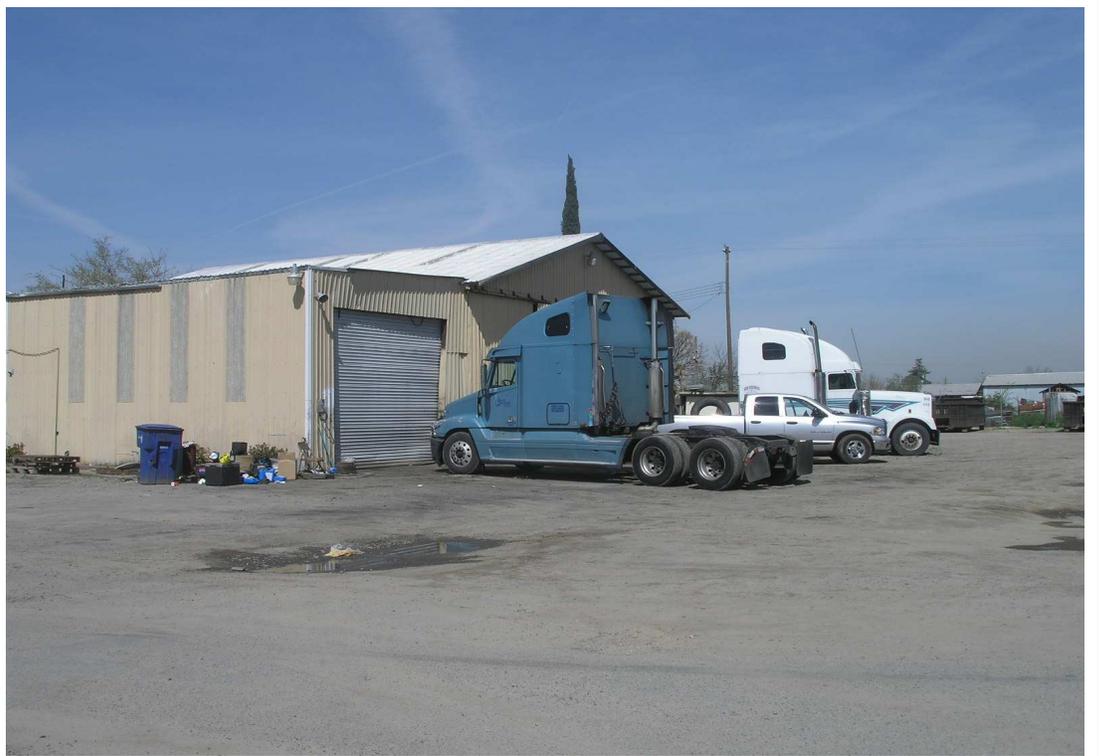
<p>Photo No. 14</p>
<p>Direction Photo Taken: Looking north</p>
<p>Description: One of the shop buildings is used for truck maintenance. Used oil, filters and other potentially hazardous materials were observed in this area.</p>

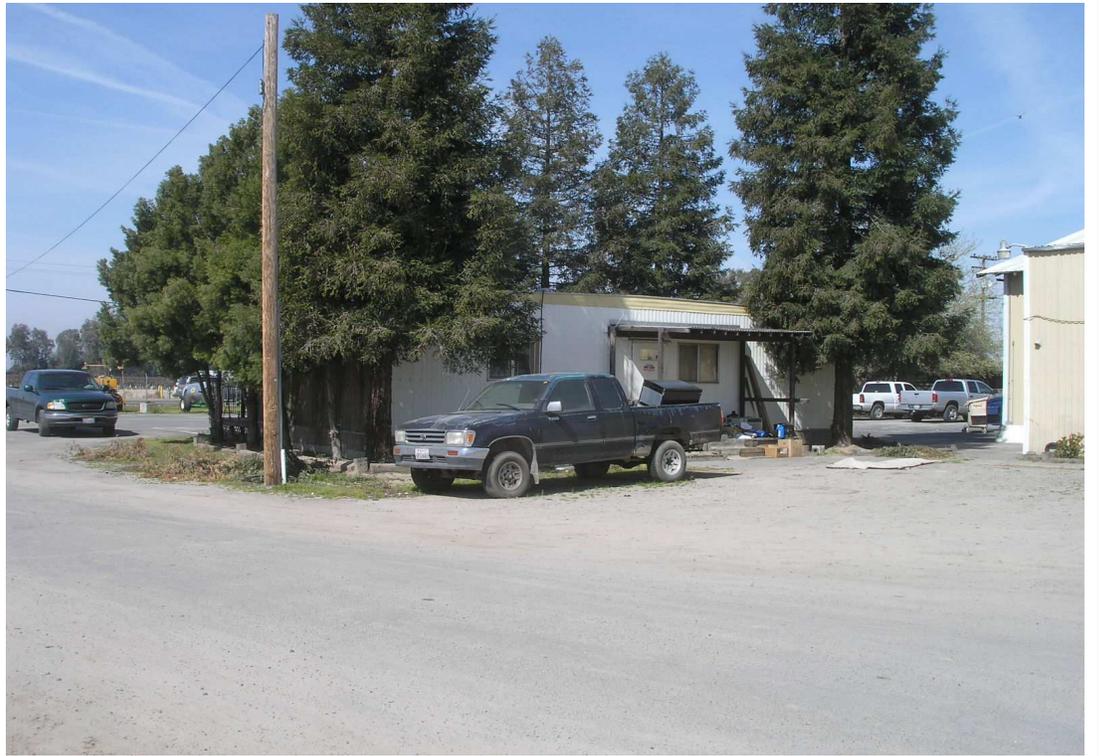
<p>Photo No. 15</p>
<p>Direction Photo Taken: Looking northwest</p>
<p>Description: Mobile home used by the trucking company as an office.</p>

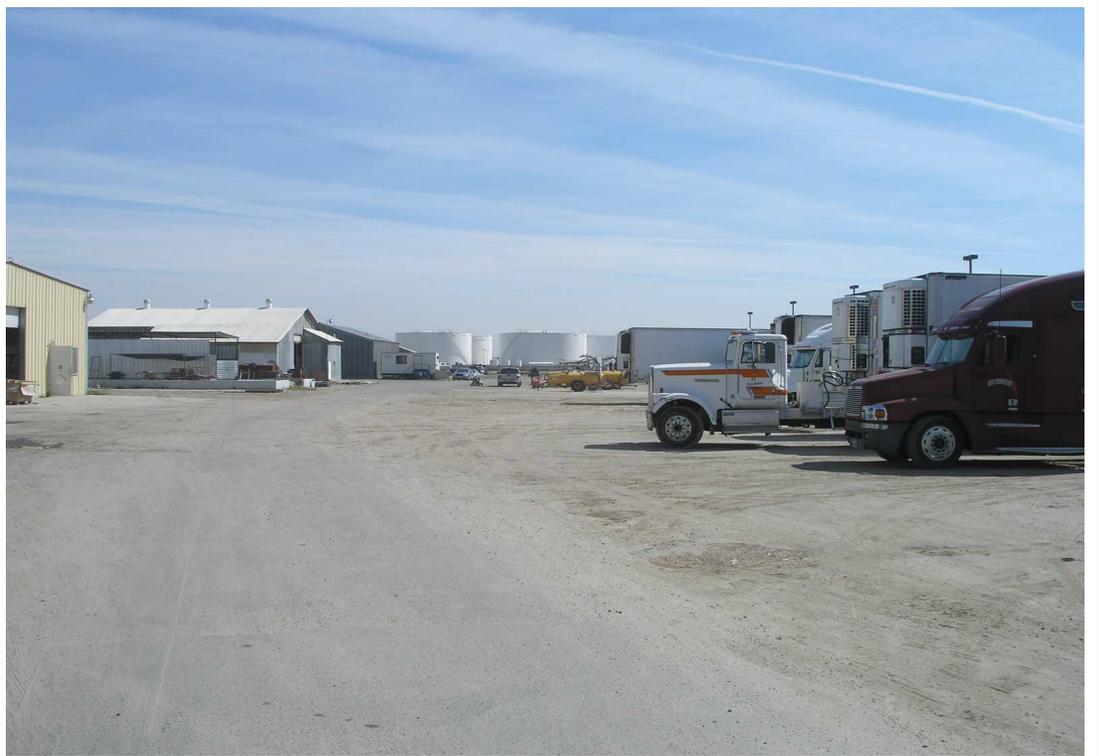
<p>Photo No. 16</p>
<p>Direction Photo Taken: Looking east</p>
<p>Description: View of the site from the south entrance. The large ASTs in the background are located at the Kinder Morgan fuel terminal beyond the site and BNSF tracks.</p>

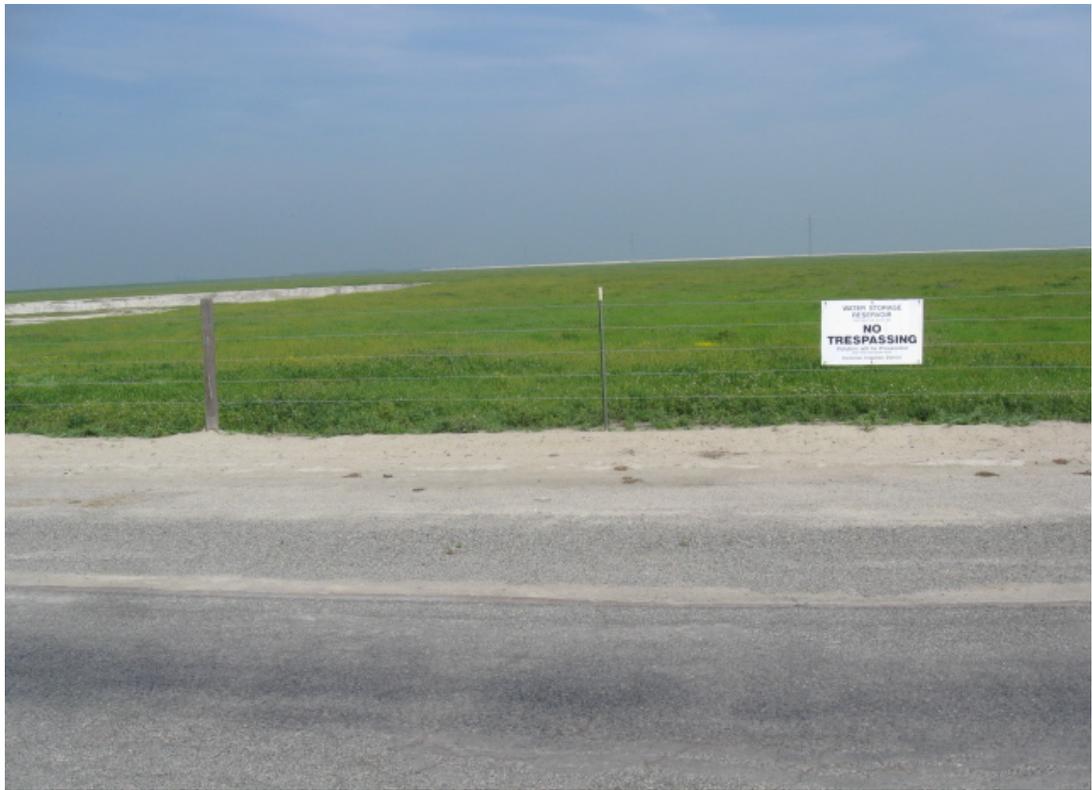
<p>Photo No. 1</p>

<p>Direction Photo Taken: Looking east</p>	
<p>Description: View of the landfill site from Highway 43. Sign states that the site is managed by the Corcoran Irrigation District.</p>

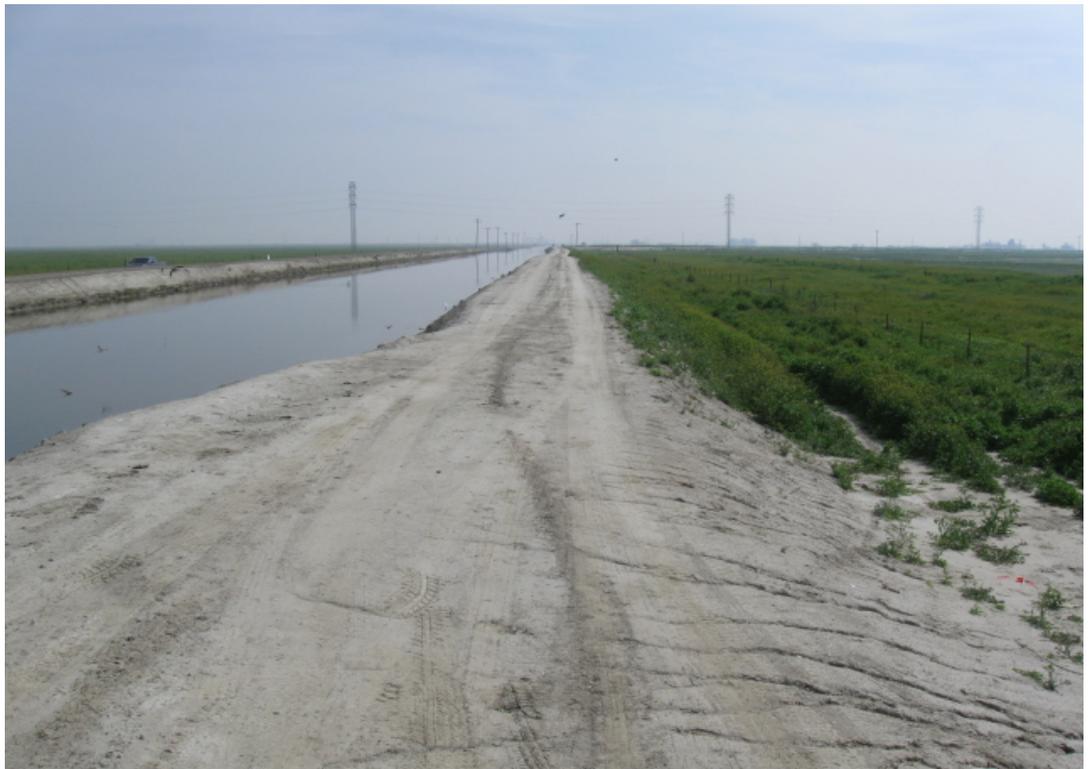
<p>Photo No. 2</p>

<p>Direction Photo Taken: Looking east</p>	
<p>Description: View of the north side of the landfill site abutting the Sweet Canal.</p>

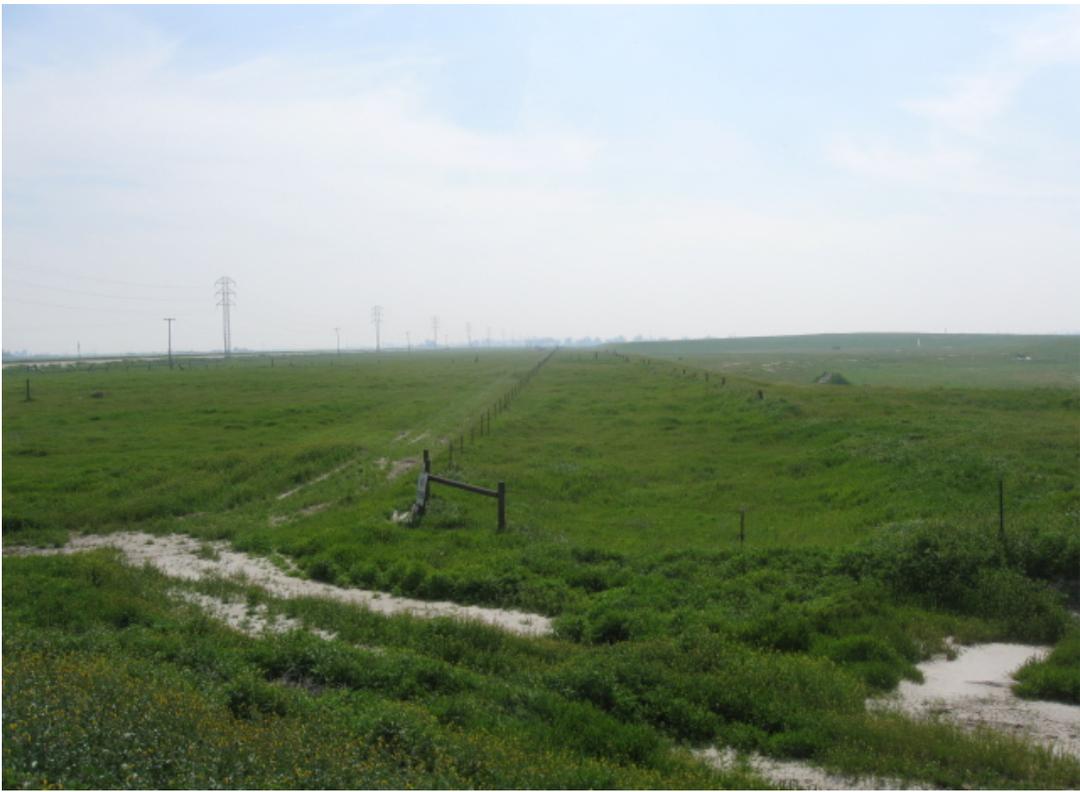
<p>Photo No. 3</p>

<p>Direction Photo Taken: Looking south</p>	
<p>Description: View of the east side of the landfill from the northeast corner of the site.</p>

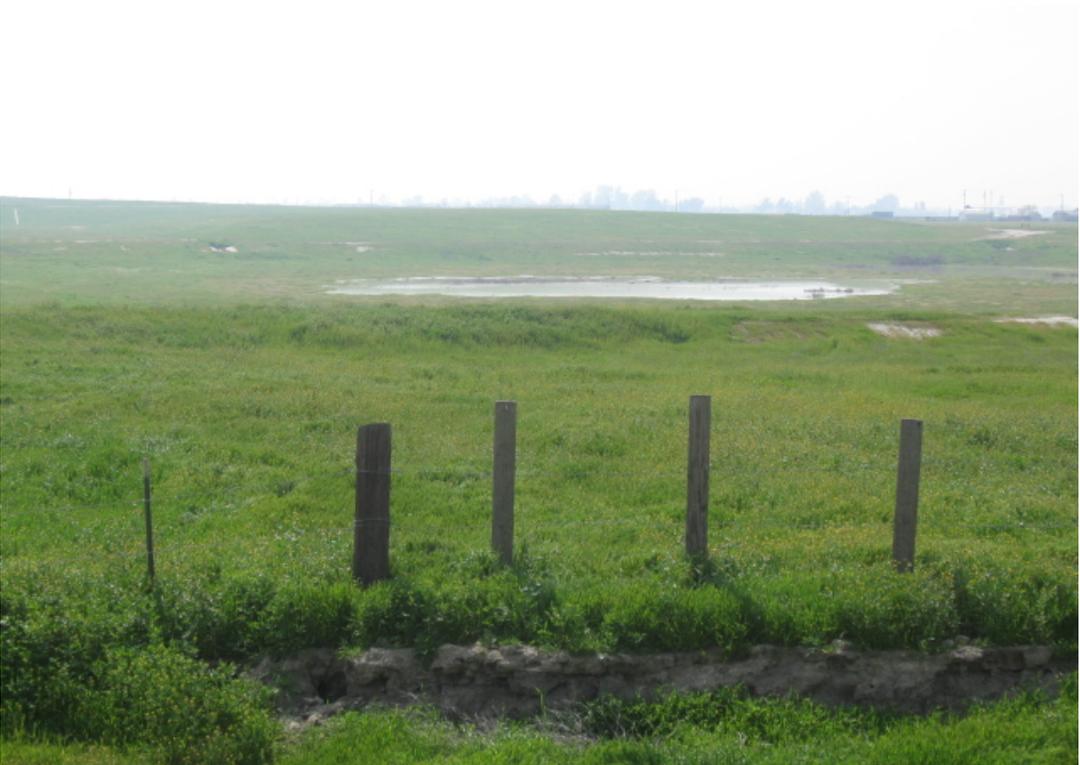
<p>Photo No. 4</p>

<p>Direction Photo Taken: Looking west</p>	
<p>Description: View of the former borrow pit located at the north end of the site. The excavation is reportedly used as a water storage reservoir by the Corcoran Irrigation District.</p>

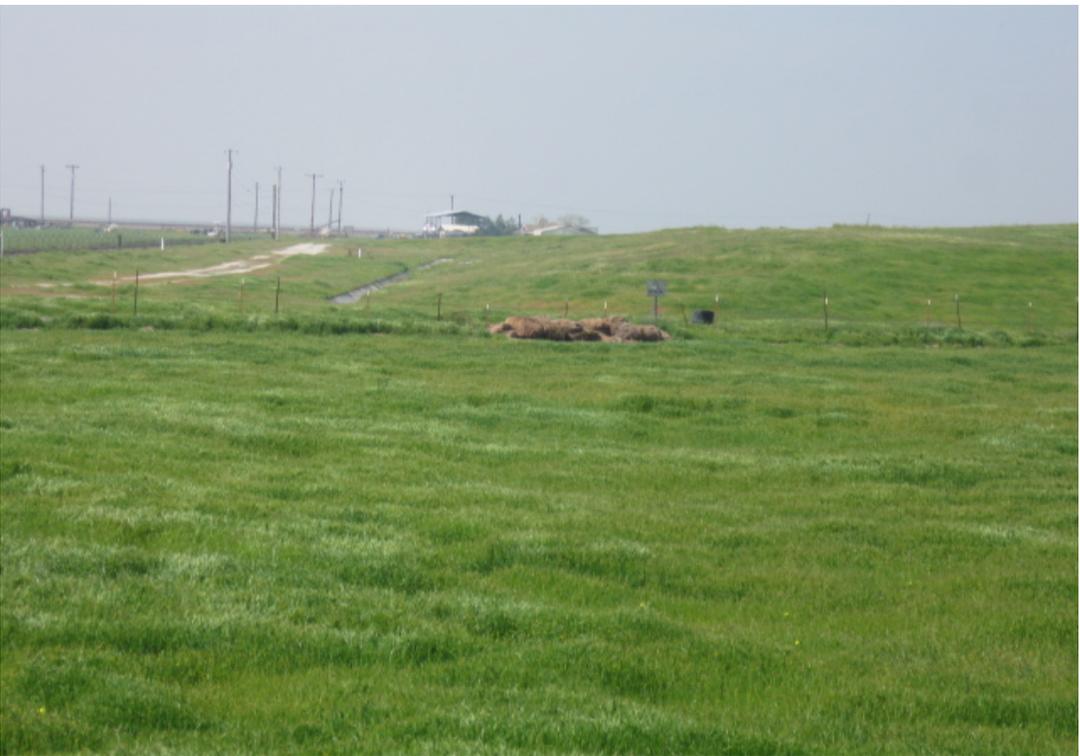
<p>Photo No. 5</p>

<p>Direction Photo Taken: Looking west</p>	
<p>Description: View of the south end of the landfill (beyond the fence). Note the lined drainage system to the left of the cap to control infiltration and runoff.</p>

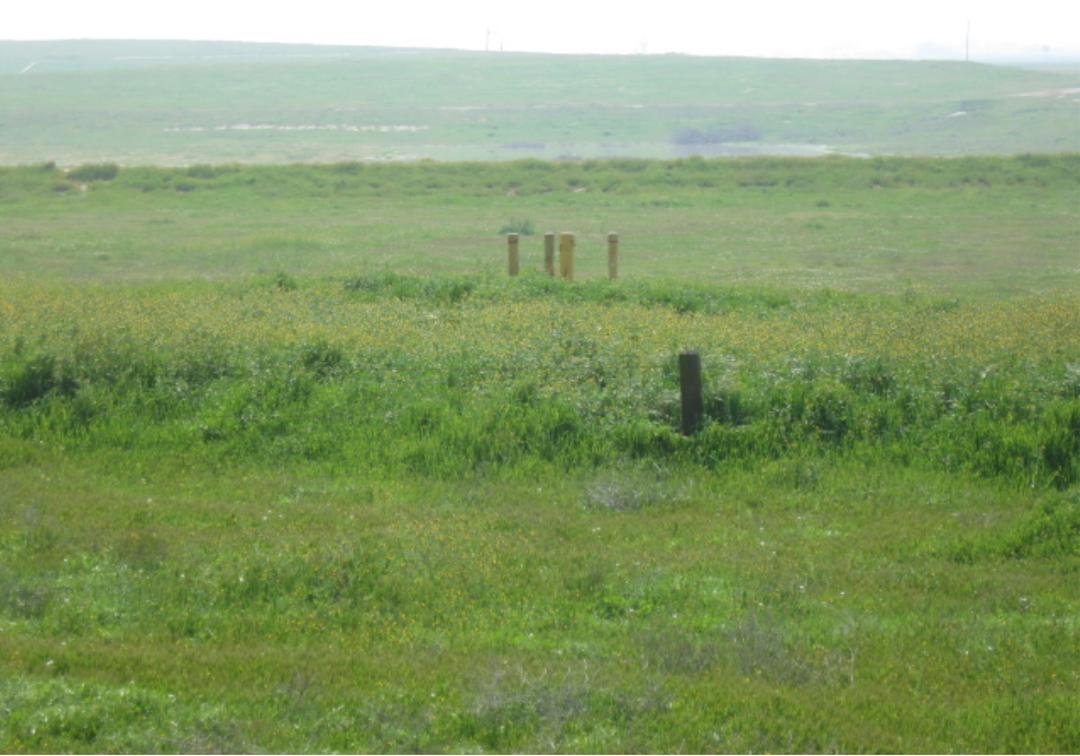
<p>Photo No. 6</p>

<p>Direction Photo Taken: Looking southwest</p>	
<p>Description: View showing several site monitoring wells on the north side of the former borrow pit.</p>

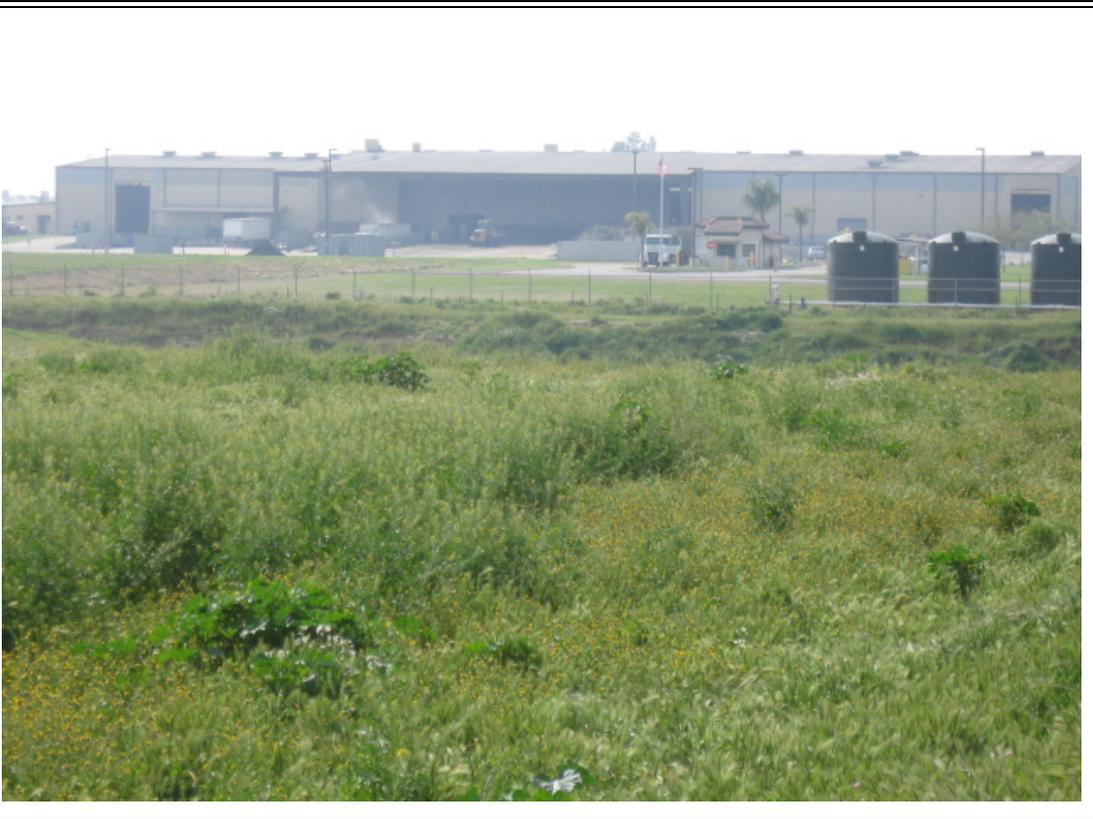
<p>Photo No. 3</p>

<p>Direction Photo Taken: Looking south</p>	
<p>Description: South end of the site and the recycling center.</p>

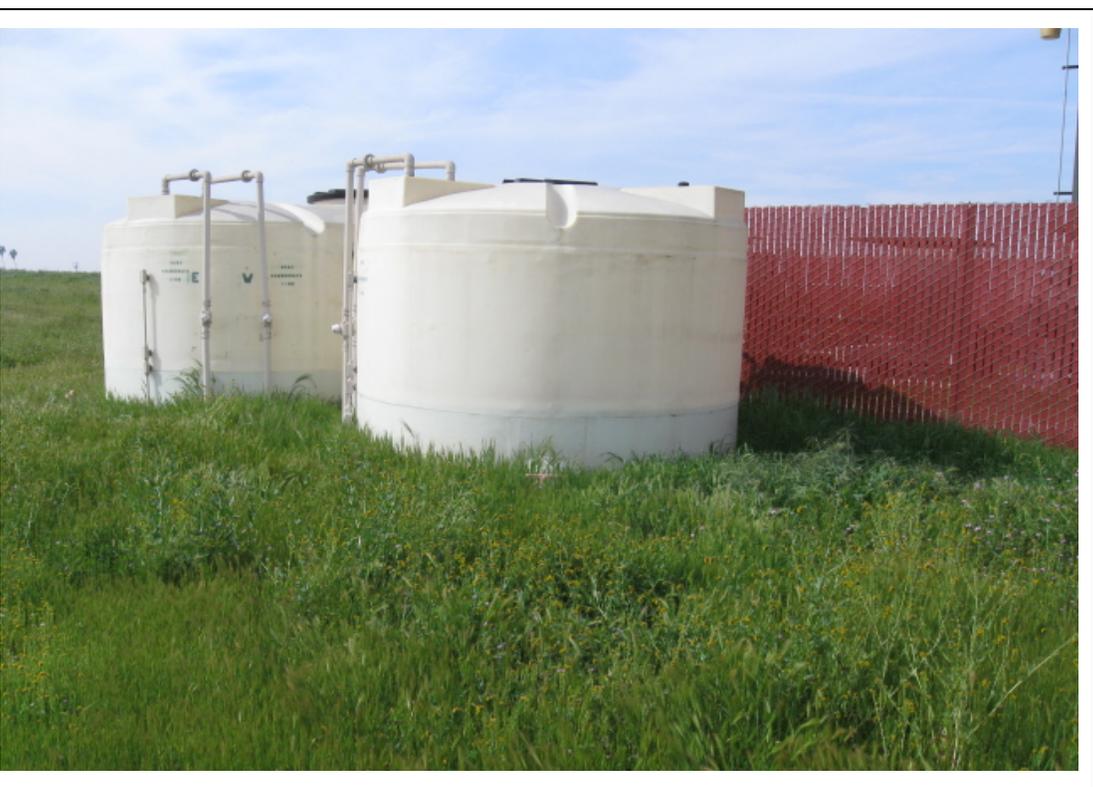
<p>Direction Photo Taken: Looking west</p>	
<p>Description: Storage tanks for the groundwater remediation system.</p>

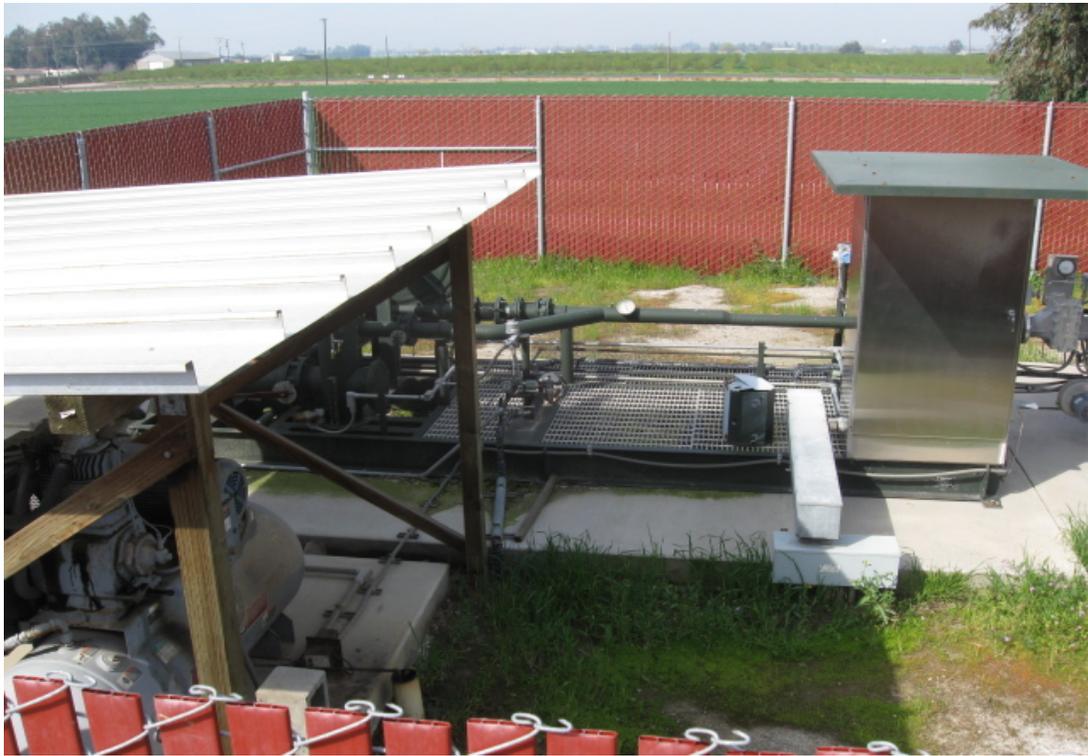
<p>Photo No. 5</p>

<p>Direction Photo Taken: Looking west</p>	
<p>Description: Remediation system.</p>

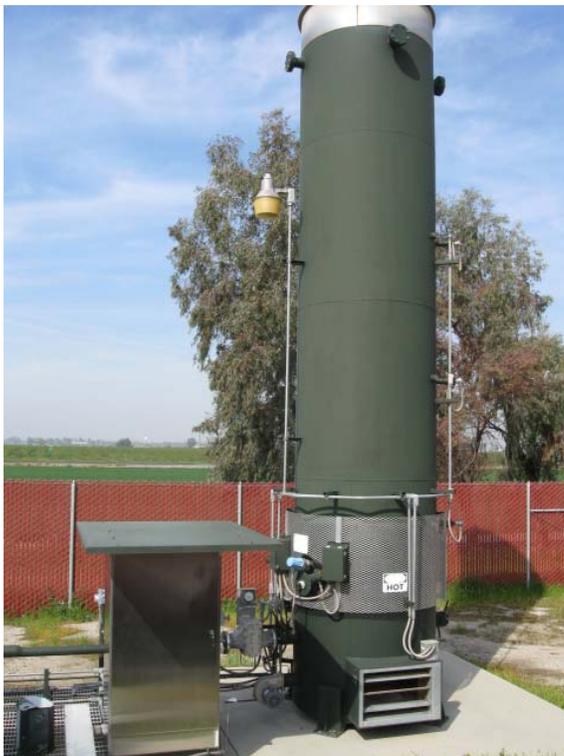
<p>Photo No. 6</p>

<p>Direction Photo Taken: Looking west</p>	
<p>Description: Another part of the remediation system.</p>
