Appendix D

Phase I Site Reconnaissance, Field Notes, Photographs, and Photo Logs Part 2

<p>California High Speed Train</p>	<p>Fresno to Bakersfield Baseline Conditions Report Bowen Engineering & Environmental 4664 S Cedar, Fresno, CA 93725</p>	<p>URS Project No. 27560811.53090100 Date: 3-16-10</p>
---	---	--

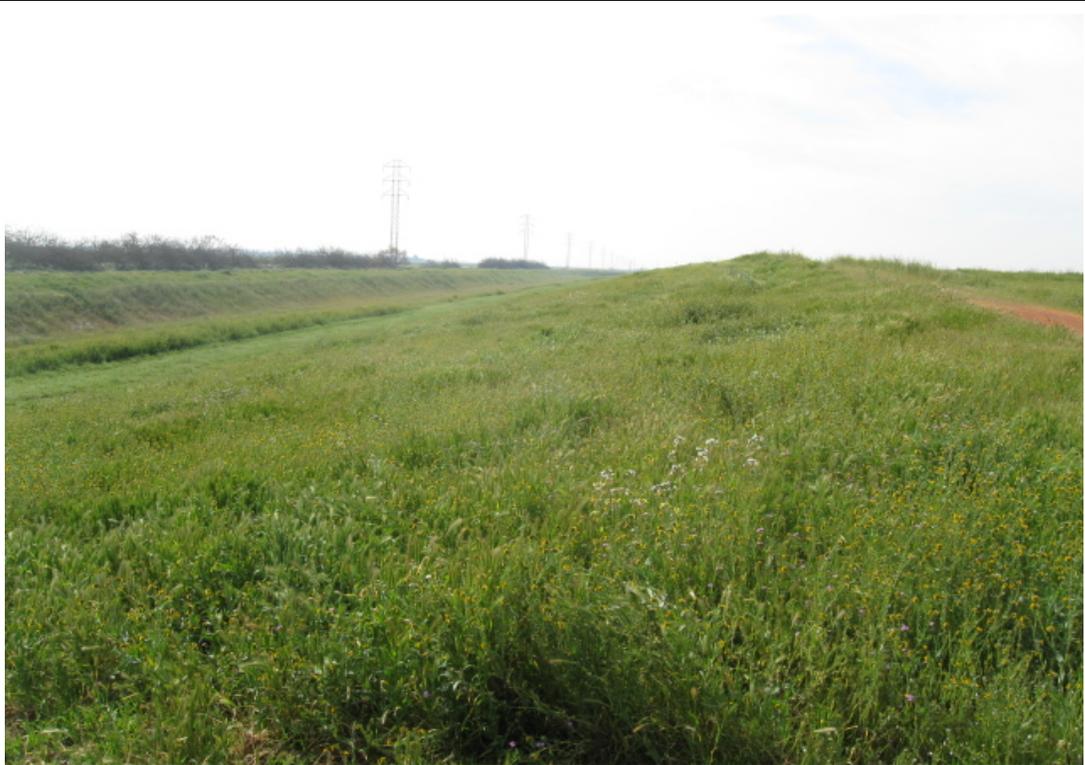
<p>Photo No. 7</p>

<p>Direction Photo Taken: Looking south</p>	
<p>Description: View of the west side of the landfill and the storm water impoundment.</p>

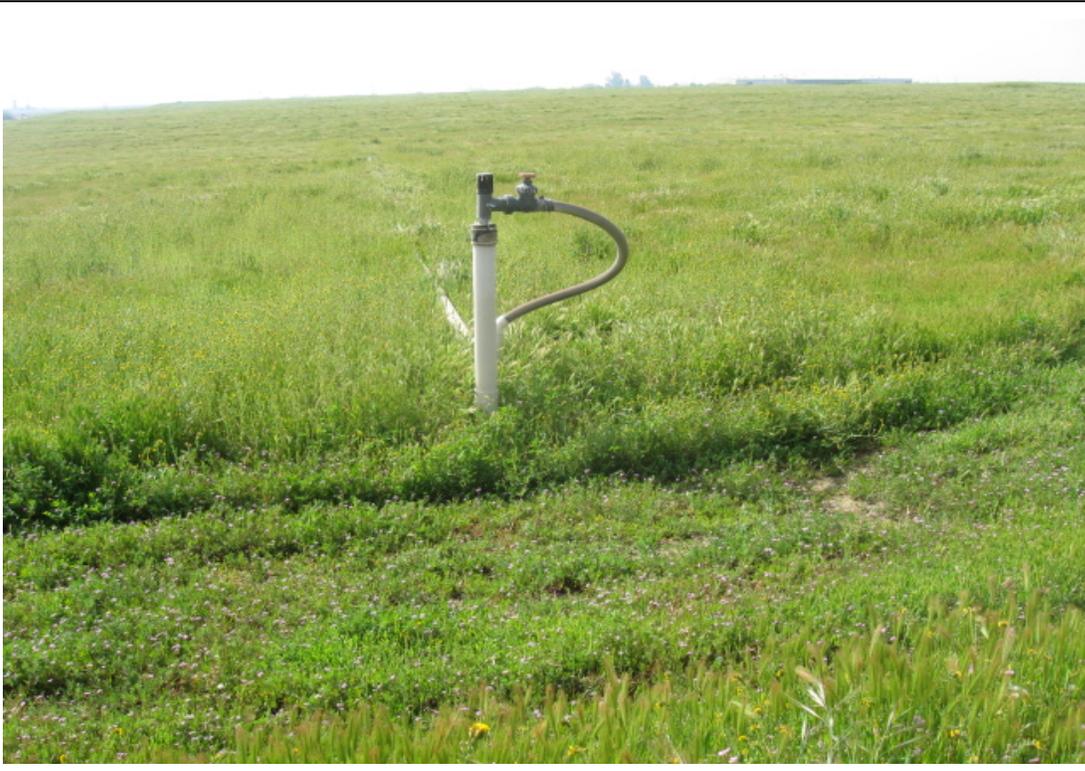
<p>Photo No. 8</p>

<p>Direction Photo Taken: Looking south</p>	
<p>Description: Close-up of an extraction system wellhead.</p>

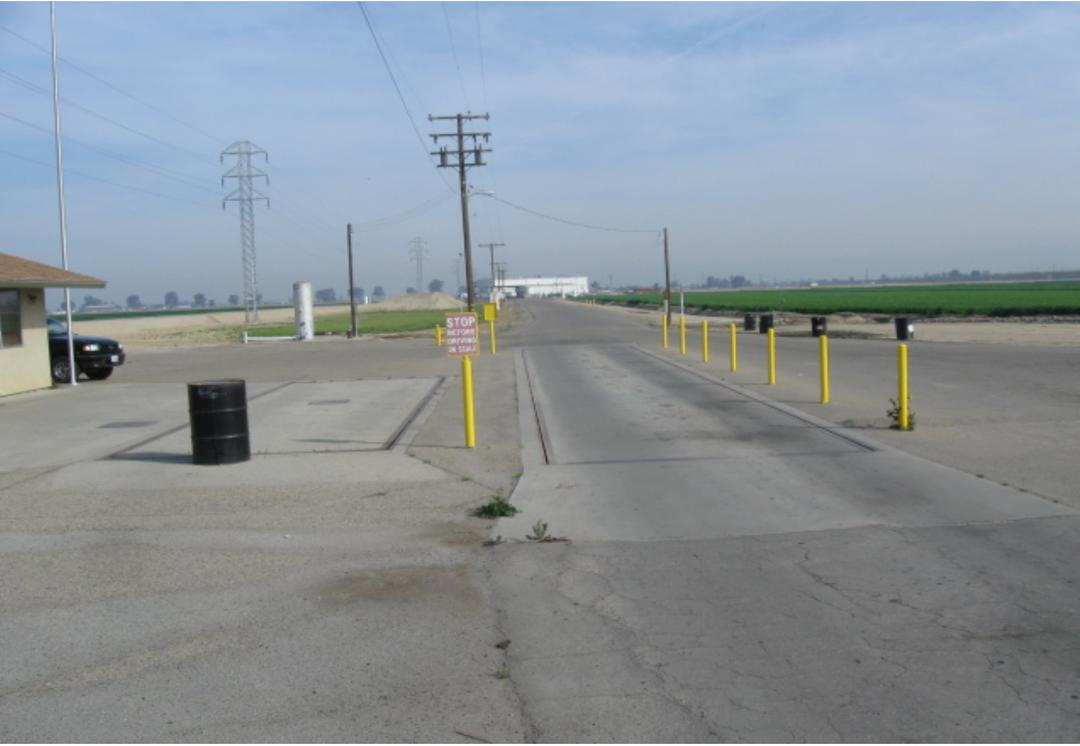
<p>Photo No. 2</p>

<p>Direction Photo Taken: Looking north</p>	
<p>Description: Scales and scale house at the plant entrance. The plant is the structure in the distance. The proposed alignment alternative lies along this driveway.</p>

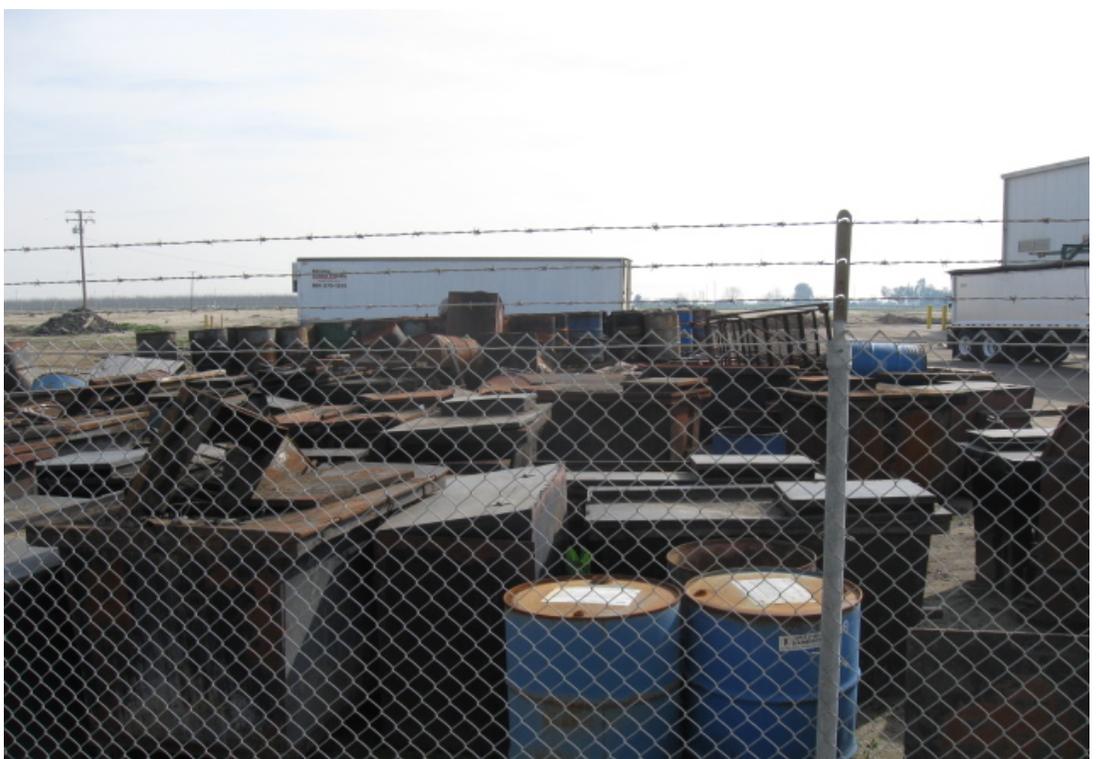
Photo No.
4

“Grease” bins and drums stored near the northwest corner of the site.

Many Unlabeled drums behind facility, presumably for Grease (& Grease Bins)

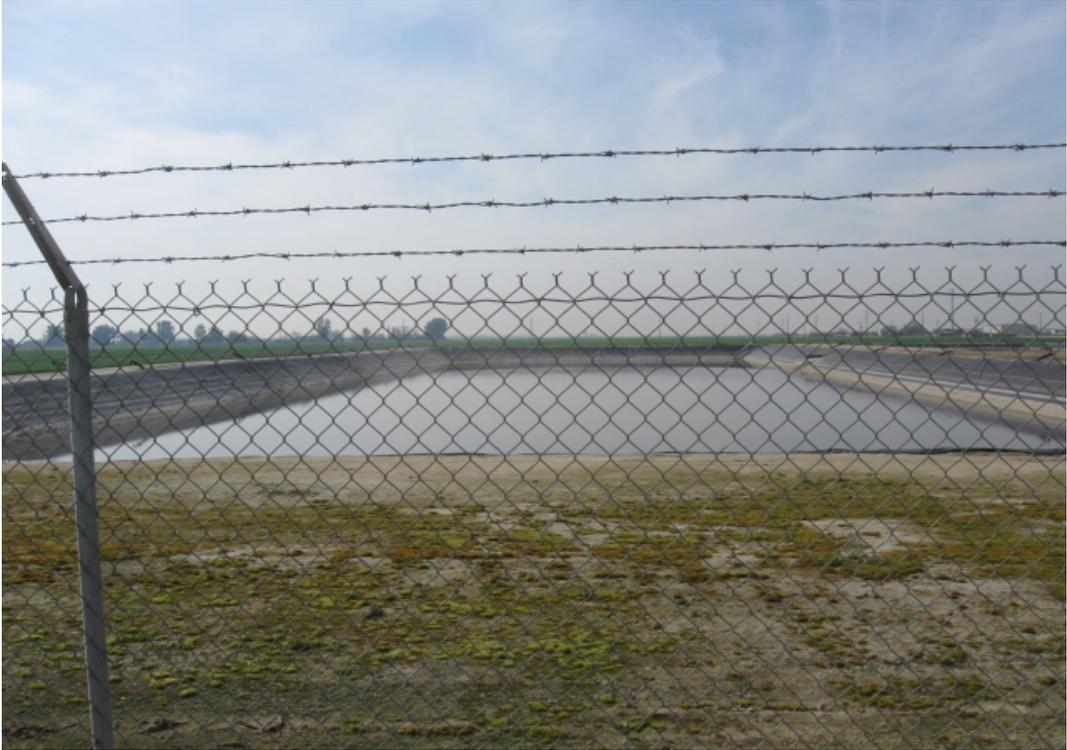
<p>Photo No. 7</p>

<p>Direction Photo Taken: Looking south</p>	
<p>Description: Another waste water containment pond. This pond appeared to be lined.</p>

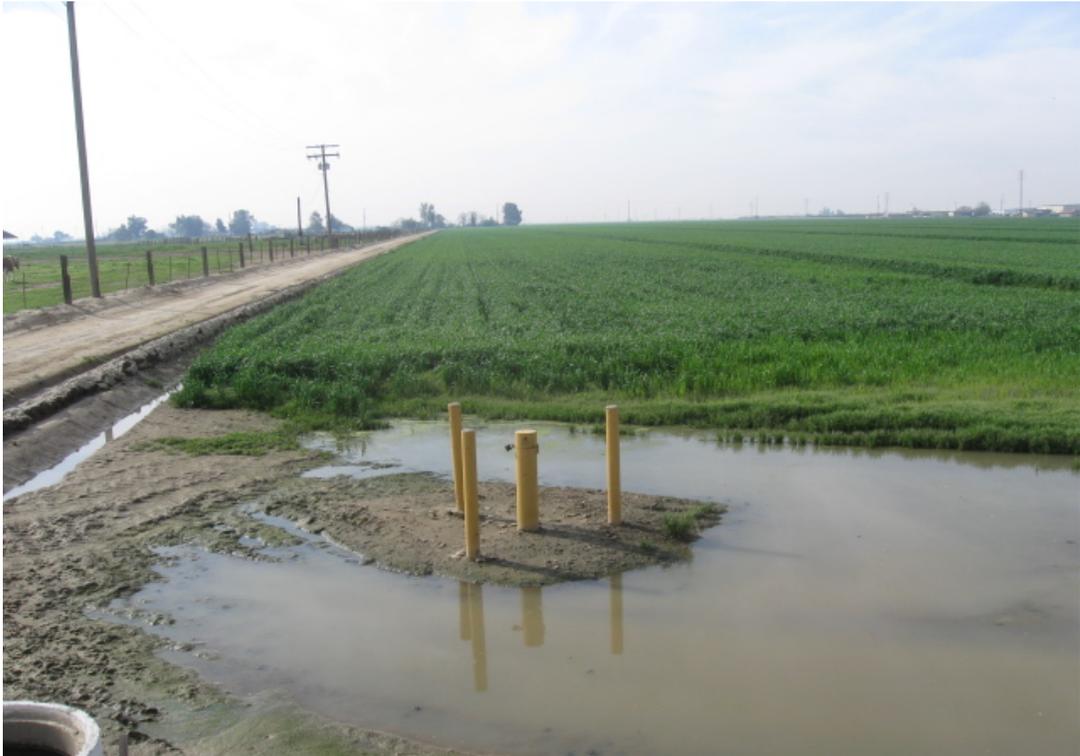
<p>Photo No. 8</p>

<p>Direction Photo Taken: Looking south</p>	
<p>Description: One of several groundwater monitoring wells observed on or near the site.</p>

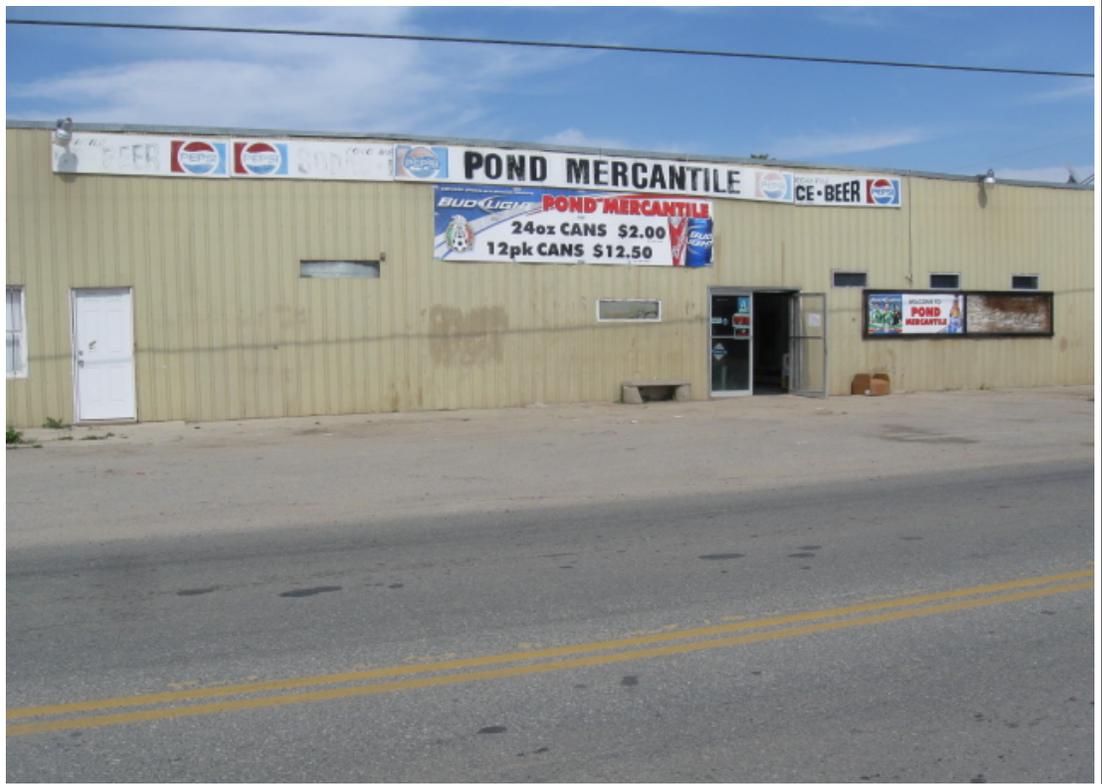
<p>Photo No. 1</p>	
<p>Direction Photo Taken: Looking north</p>	
<p>Description: Front side of the site along Pond Road. Groundwater monitoring wells are located here.</p>

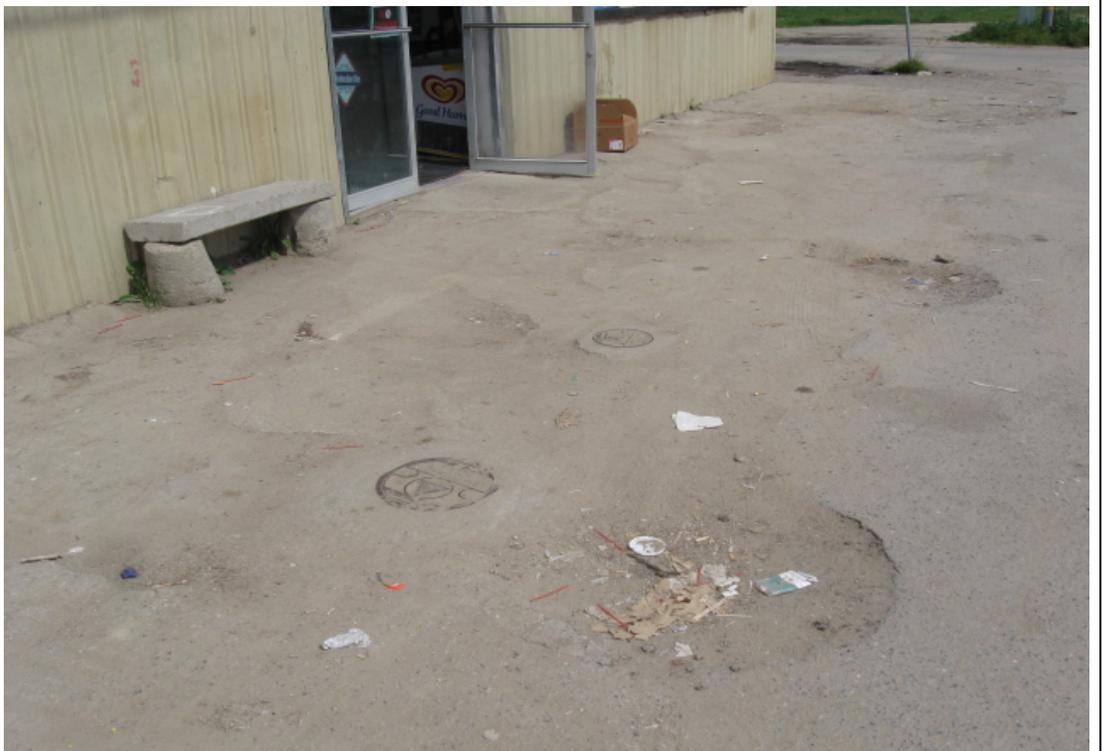
Photo No.
4

Groundwater monitoring wells on the south side of the building along Pond Road.

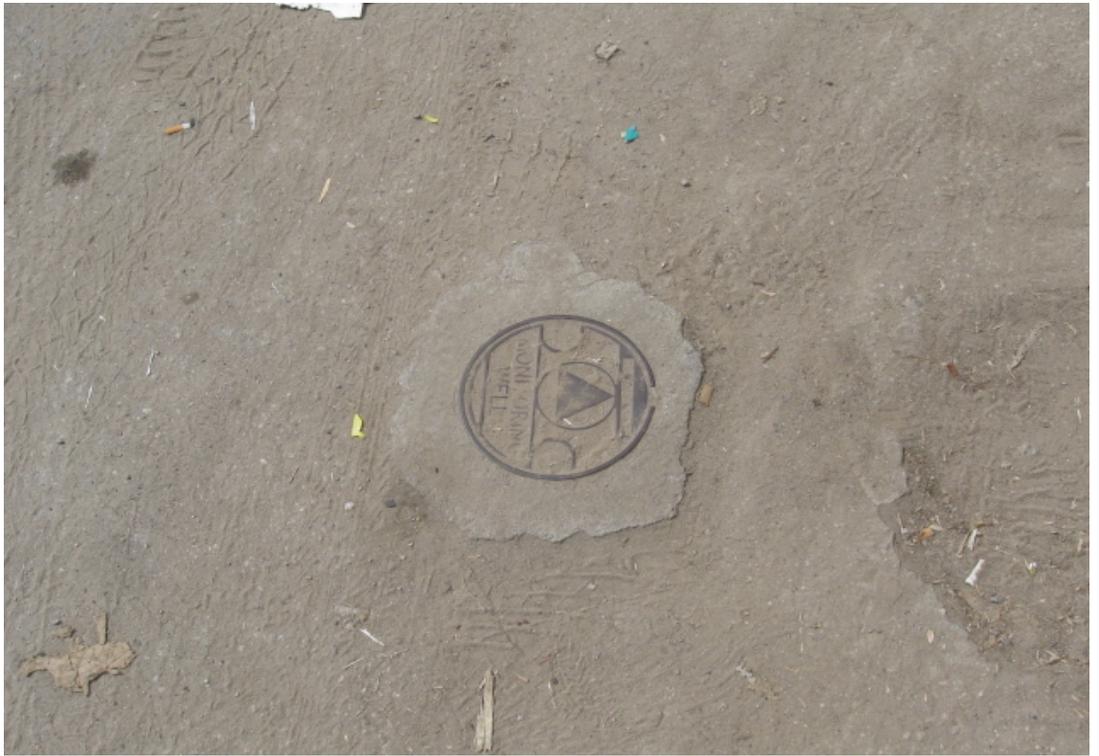
<p>Photo No. 5</p>	
<p>Direction Photo Taken: Aerial view</p>	
<p>Description: Close-up of a monitoring well on the south side of the building.</p>

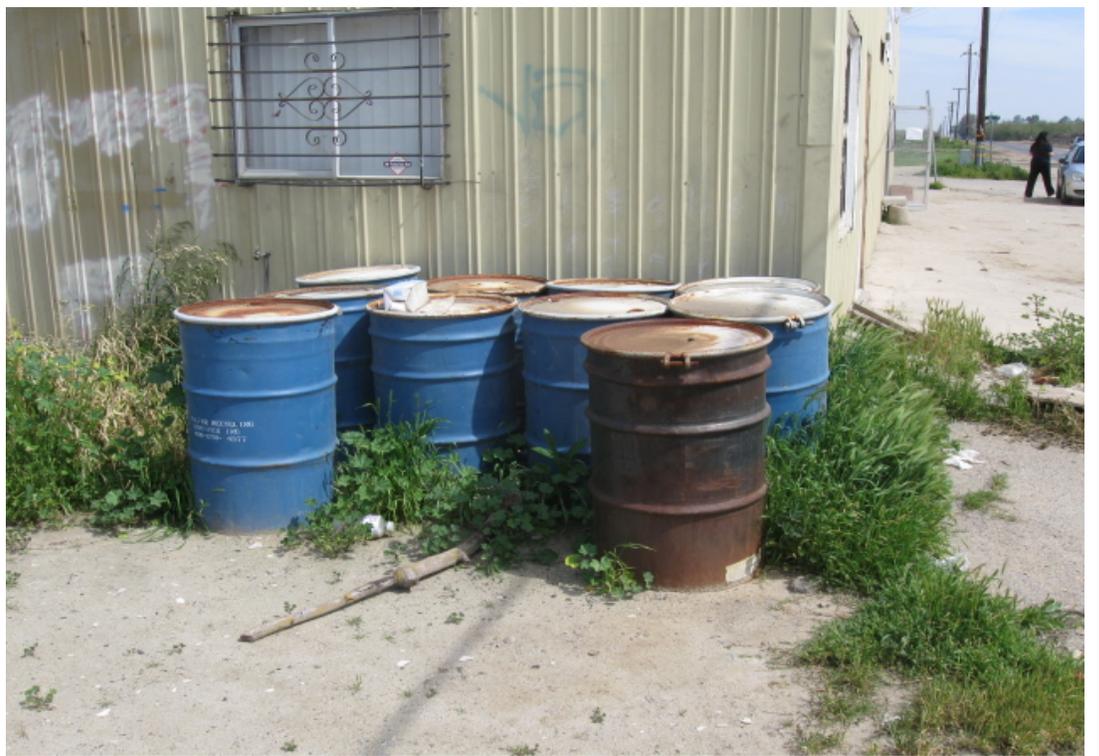
<p>Photo No. 6</p>	
<p>Direction Photo Taken: Looking east</p>	
<p>Description: Unlabeled storage drums on the west side of the site structure. Contents of the drums is unknown.</p>

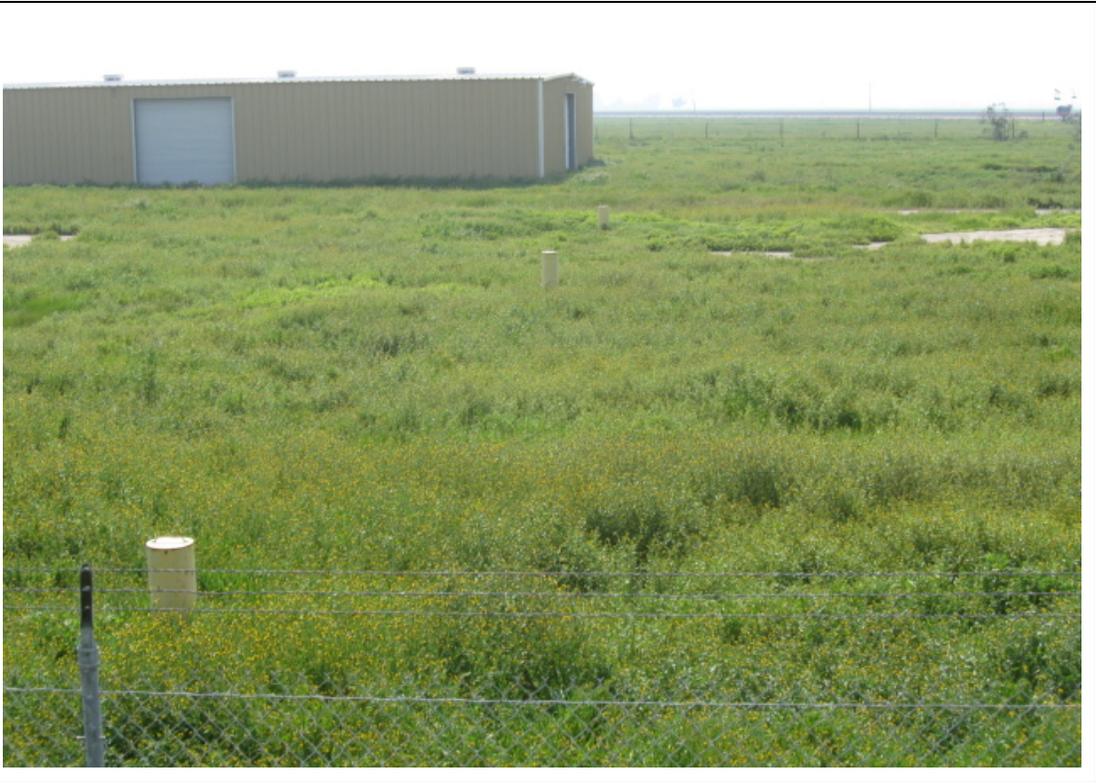
<p>Direction Photo Taken: Looking south</p>	
<p>Description: Steel building west end. Note the groundwater monitoring wells.</p>

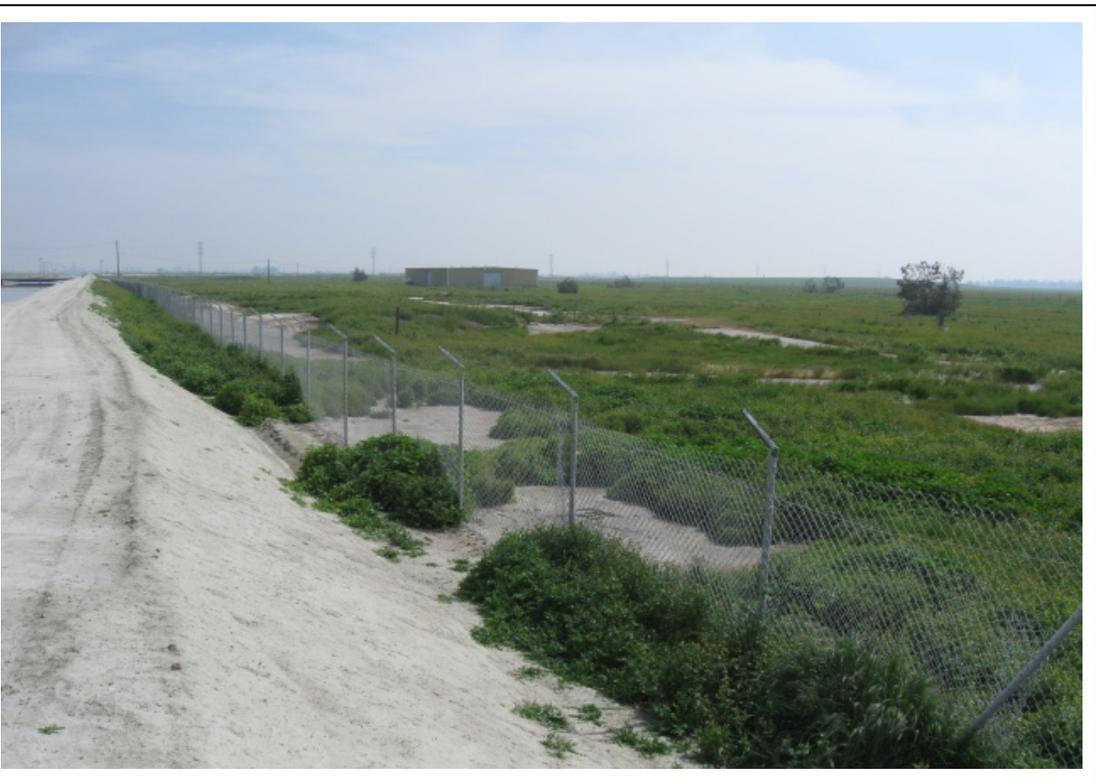
<p>Photo No. 6</p>

<p>Direction Photo Taken: Looking east</p>	
<p>Description: View of the north end of the site along Sweet Canal.</p>

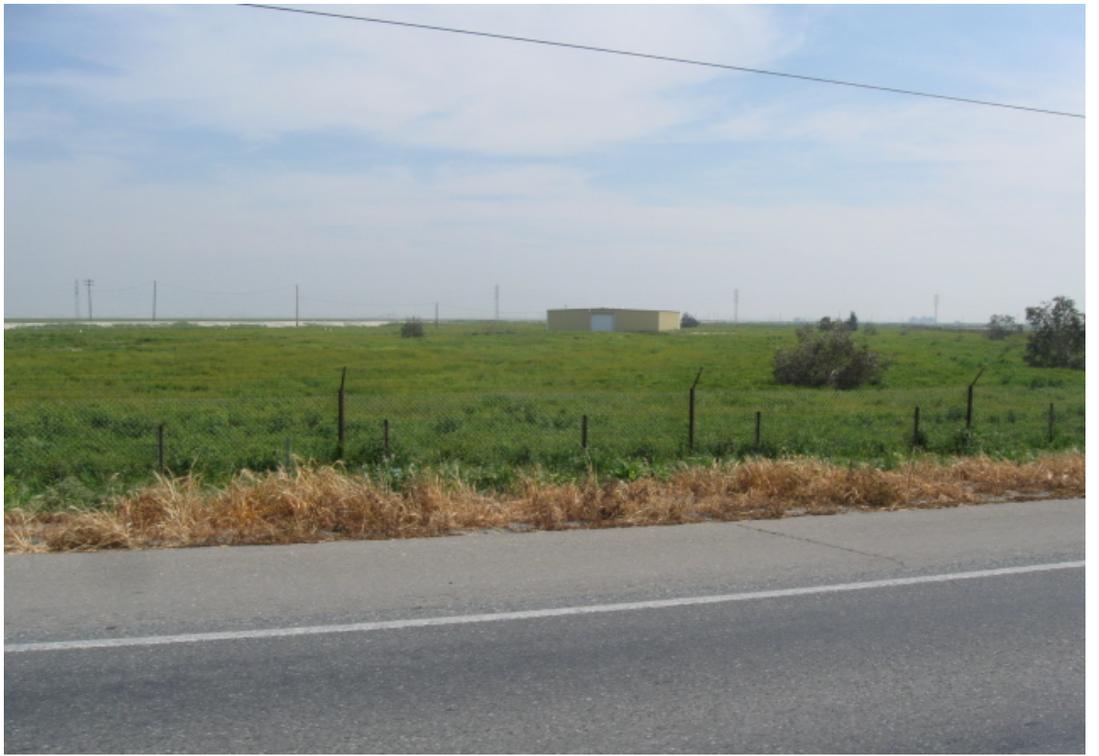
Photo No. 7
Direction Photo Taken: Looking east
Description: View of the west end of the site from Highway 43.

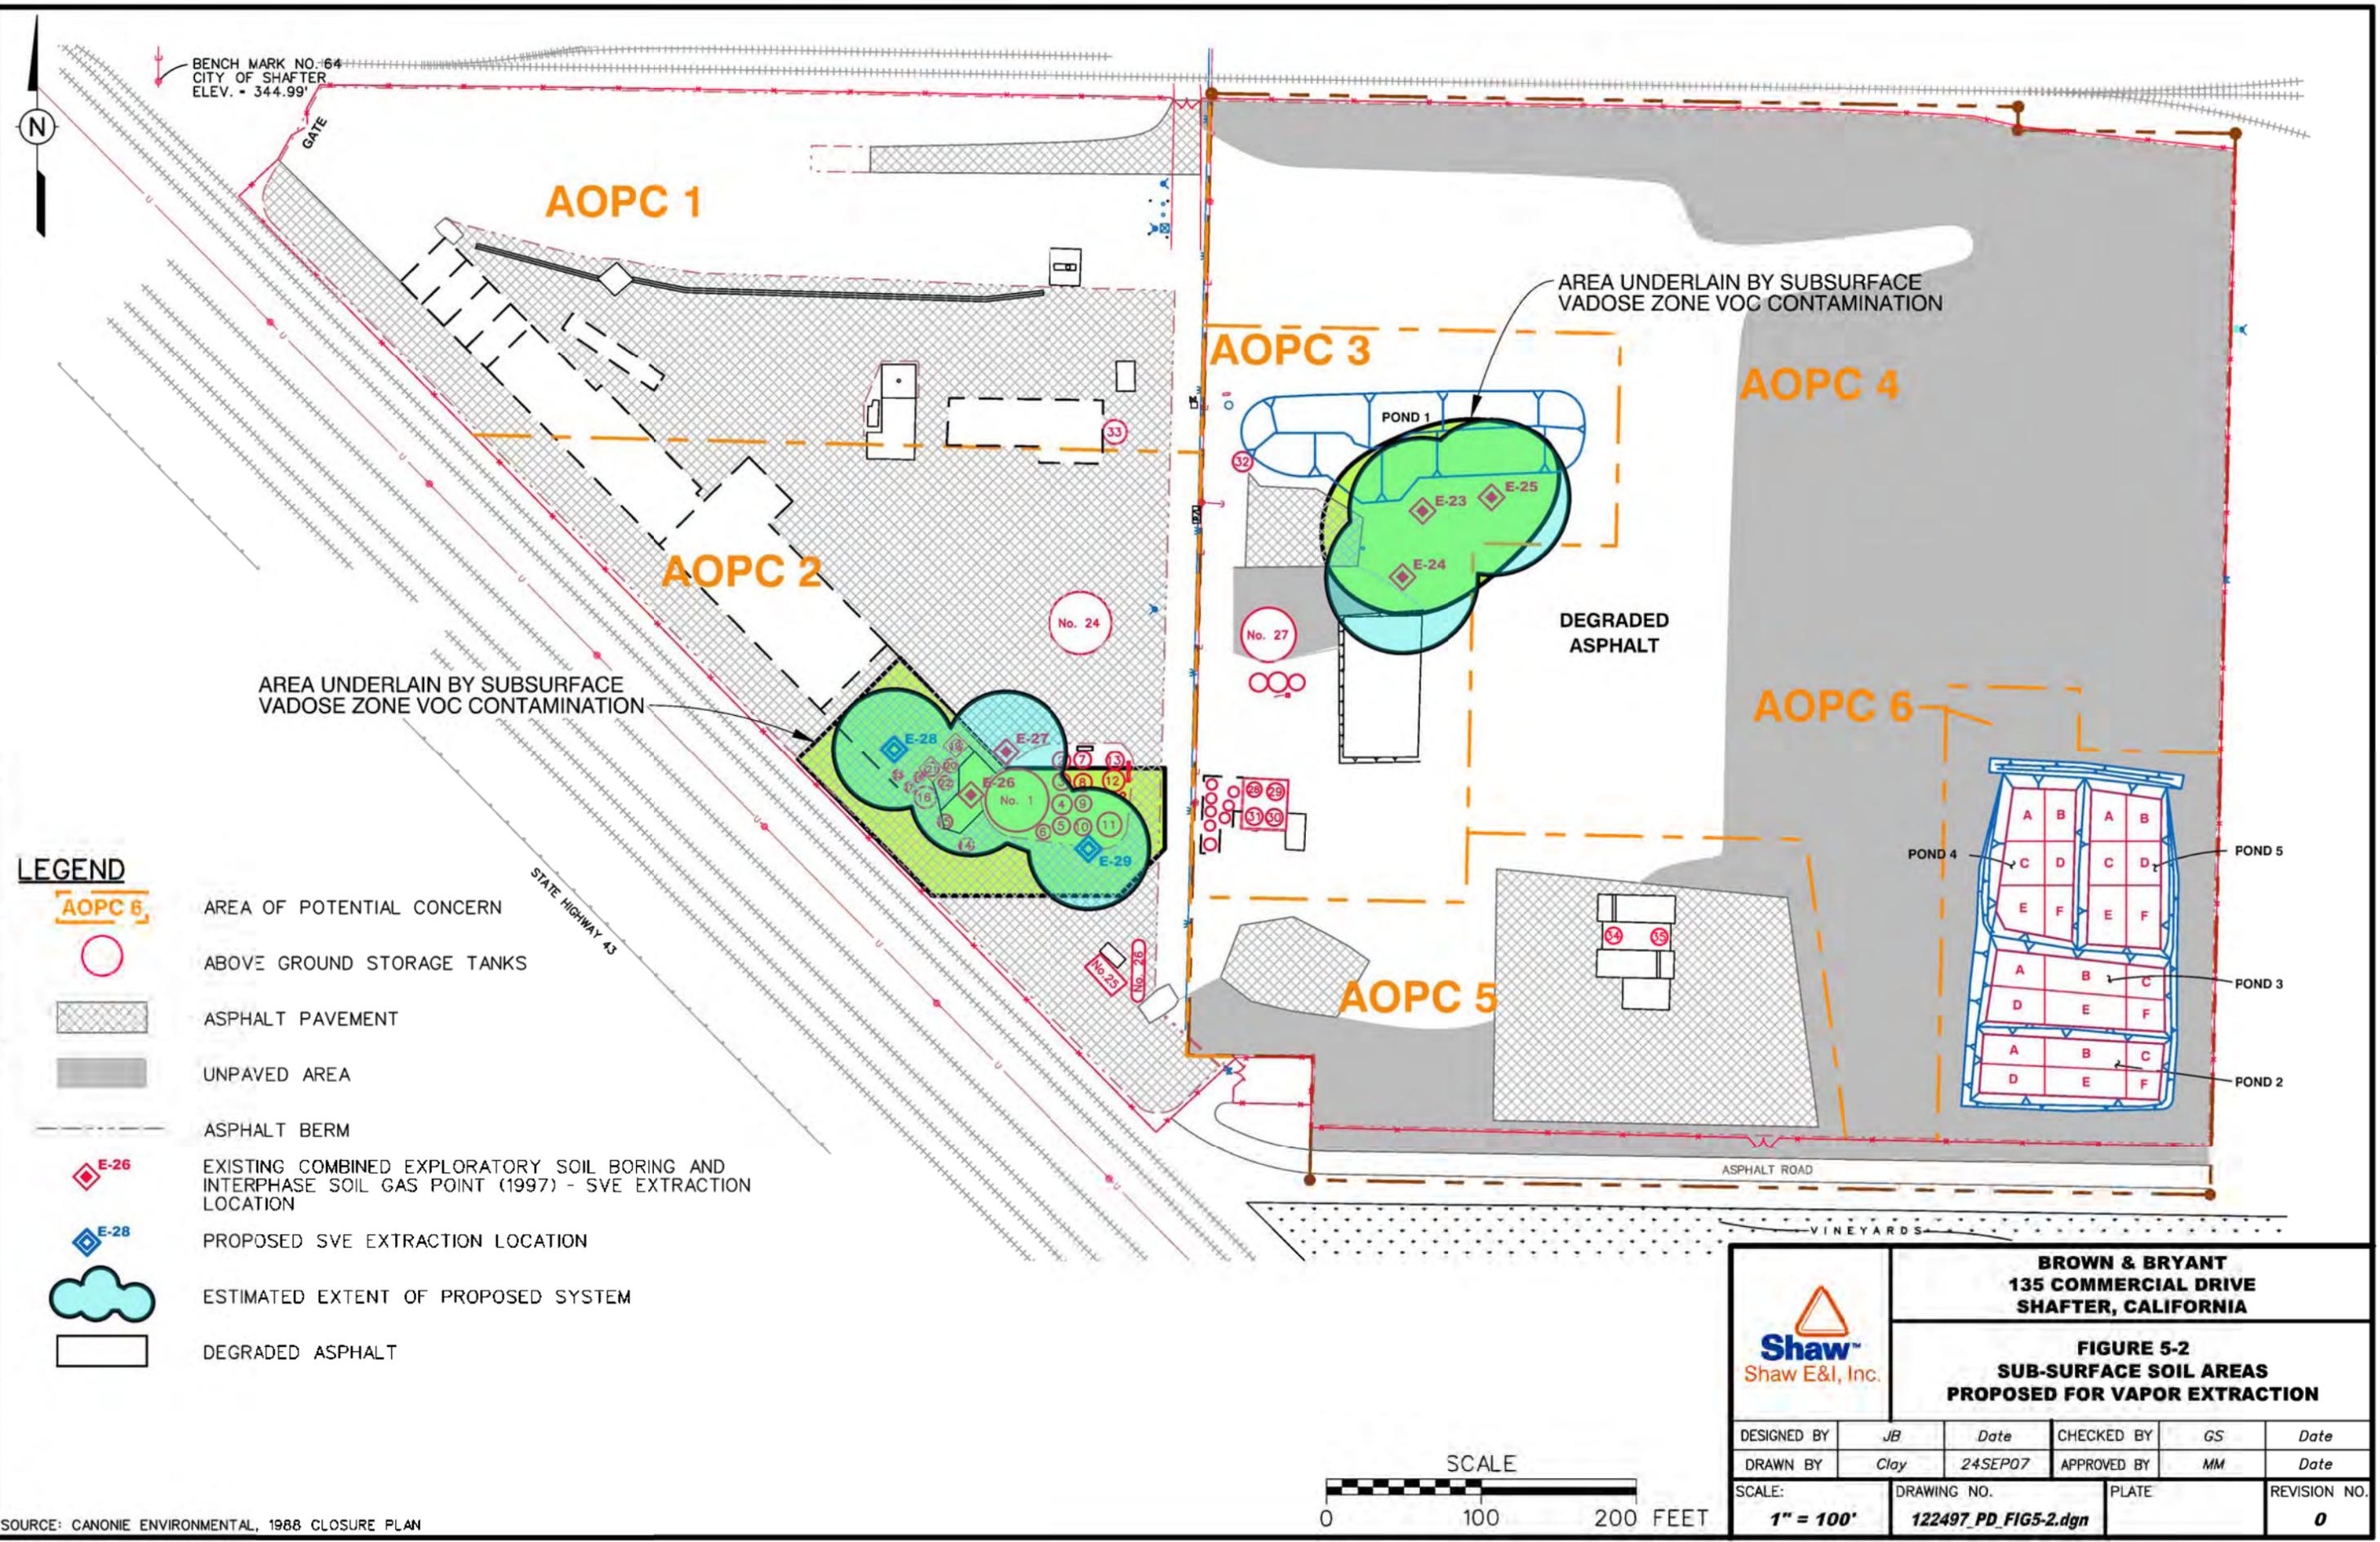
The deep soil affected with VOCs (see Figure 5-2) will be remediated using SVE. This technology involves collection of soil vapor from the unsaturated zone by applying a vacuum at a series of extraction points. The vacuum not only draws vapor from the unsaturated zone, but also decreases the pressure around the soil particles, thereby releasing additional volatiles. In addition, due to the pressure differential, clean air from the atmosphere enters the soil to replace the extracted air.

The pilot test conducted in October 2006 (Shaw, 2006) showed SVE to be a feasible and effective technology for removing the VOCs from the deep soil at this site. To provide flexibility of operation, the two impacted areas of contamination shown on Figure 5-2 will each have their own SVE system. The major components of each SVE system will include: existing and new vapor extraction wells, necessary piping and valves, and a positive displacement or regenerative blower. The discharged air from each system would be sent through two activated carbon units plumbed in series. The spent carbon would be regenerated for reuse. If carbon adsorption technology proves to be cost-prohibitive, other emission control technologies may be applied. In any case, emissions controls will meet San Joaquin Air Pollution Control District requirements for SVE treatment of VOC-contaminated soil. Sampling will be conducted during the SVE system operation to ensure compliance with air quality regulations and to determine the effectiveness of the system. Closure confirmation sampling would include confirmation of soil at depth, soil gas sampling or demonstration of an asymptotic decline. The results would be incorporated into a post remediation evaluation to insure that health-based objectives are met. A more complete protocol for this post remedial evaluation will be addressed in a remedial action work plan to be submitted for DTSC approval prior to field mobilization.

The deep soil affected with VOCs will be remediated using SVE. This technology involves collection of soil vapor from the unsaturated zone by applying a vacuum at a series of extraction points. Two impacted areas of contamination, shown on Figure 5-2, will each have their own SVE system. The major components of each SVE system will include existing and new vapor extraction wells, necessary piping and valves, and a blower. The discharged air from each system would be sent through two activated carbon units plumbed in series. The spent carbon would be regenerated for reuse. If carbon adsorption technology proves to be cost-prohibitive, other emission control technologies may be applied. In any case, emissions controls will meet San Joaquin Air Pollution Control District requirements for SVE treatment of VOC-contaminated soil. Closure confirmation sampling would include confirmation of soil at depth, soil gas sampling or demonstration of an asymptotic decline. The results would be incorporated into a post remediation evaluation to insure that health-based objectives are met

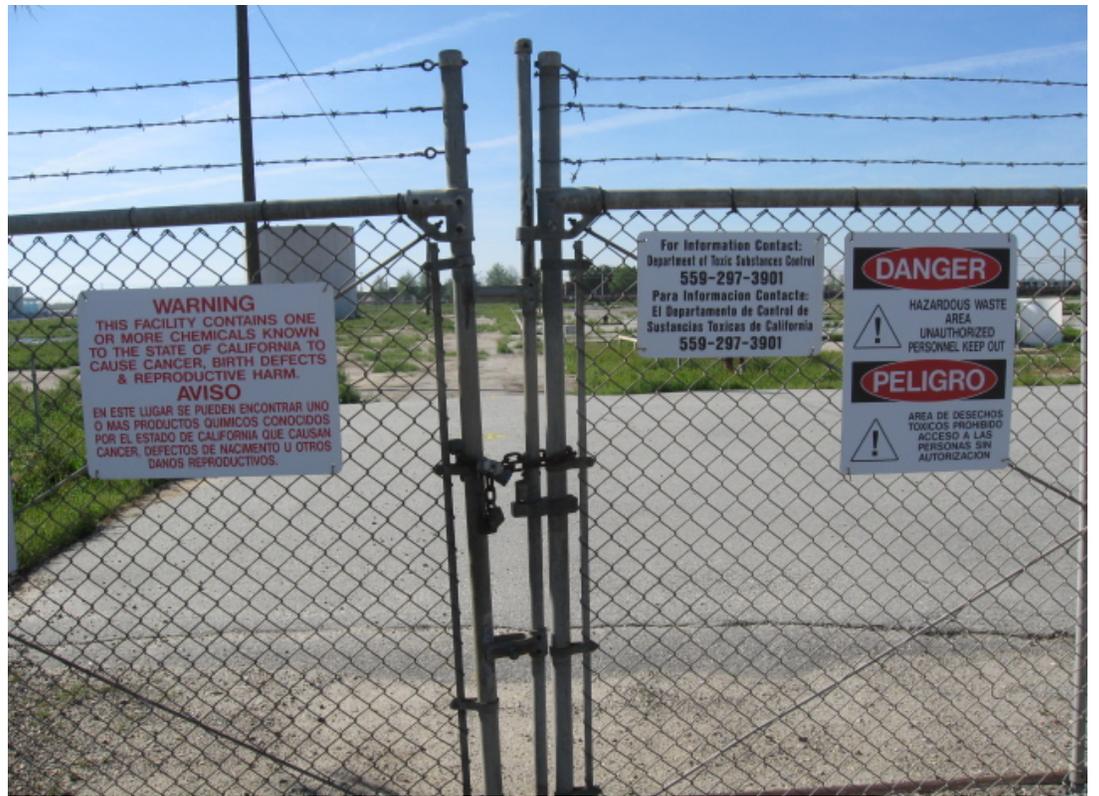
<p>Photo No. 1</p>	
<p>Direction Photo Taken: Looking south</p>	
<p>Description: Main entrance to the site on the north side. Note Hazardous Materials Warning signs.</p>

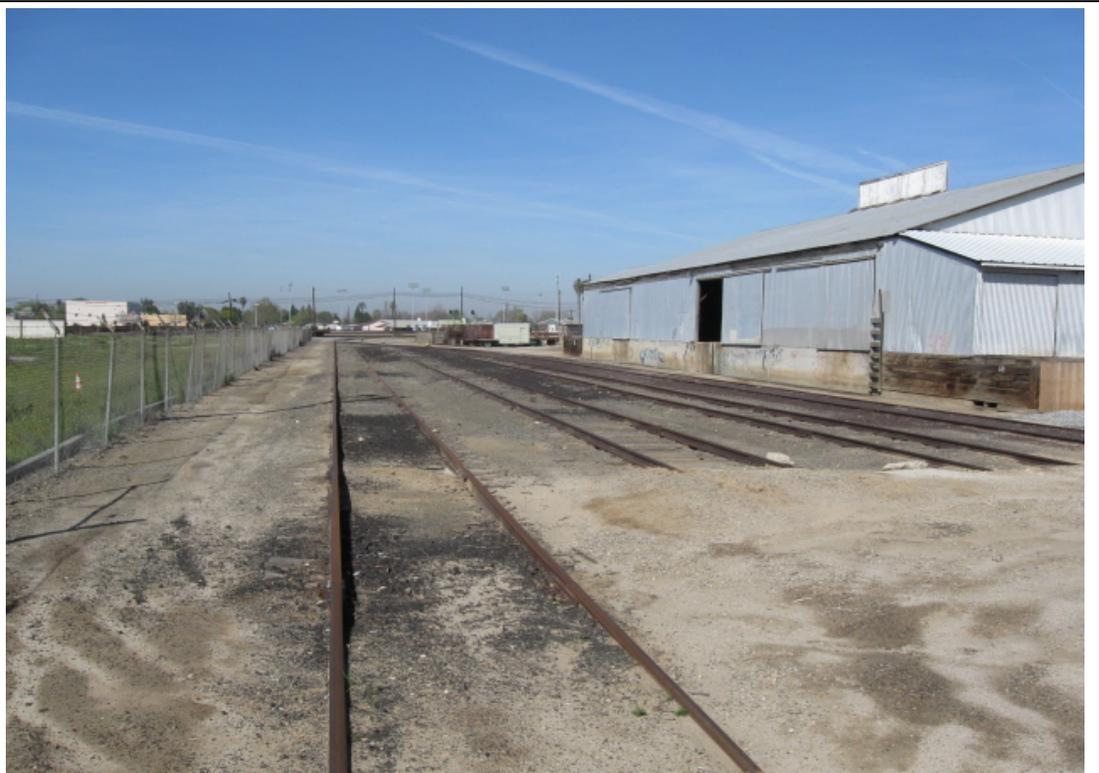
<p>Photo No. 2</p>	
<p>Direction Photo Taken: Looking west</p>	
<p>Description: View of the north side of the site (left) from the main entrance and adjacent offsite rail spurs (BNSF).</p>

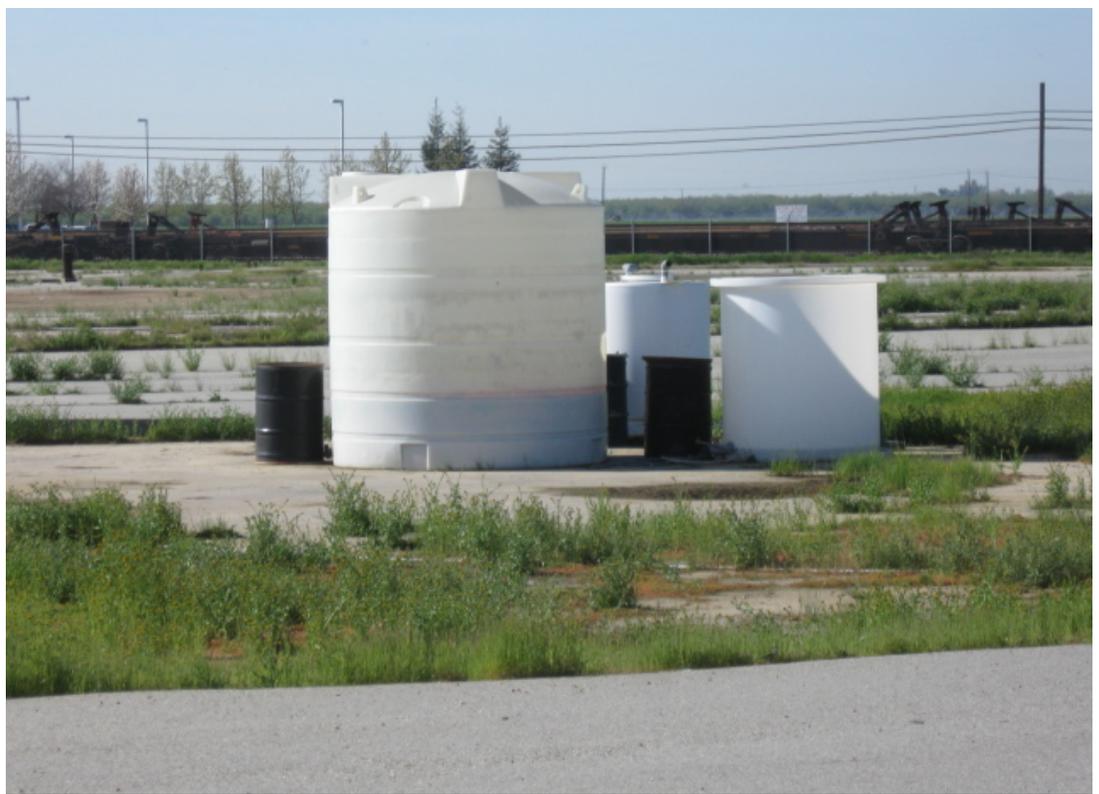
<p>Photo No. 4</p>	
<p>Direction Photo Taken: Looking southwest</p>	
<p>Description: View across the site from the northeast corner. Note the large AST and lined pond (see Photo 8 below).</p>

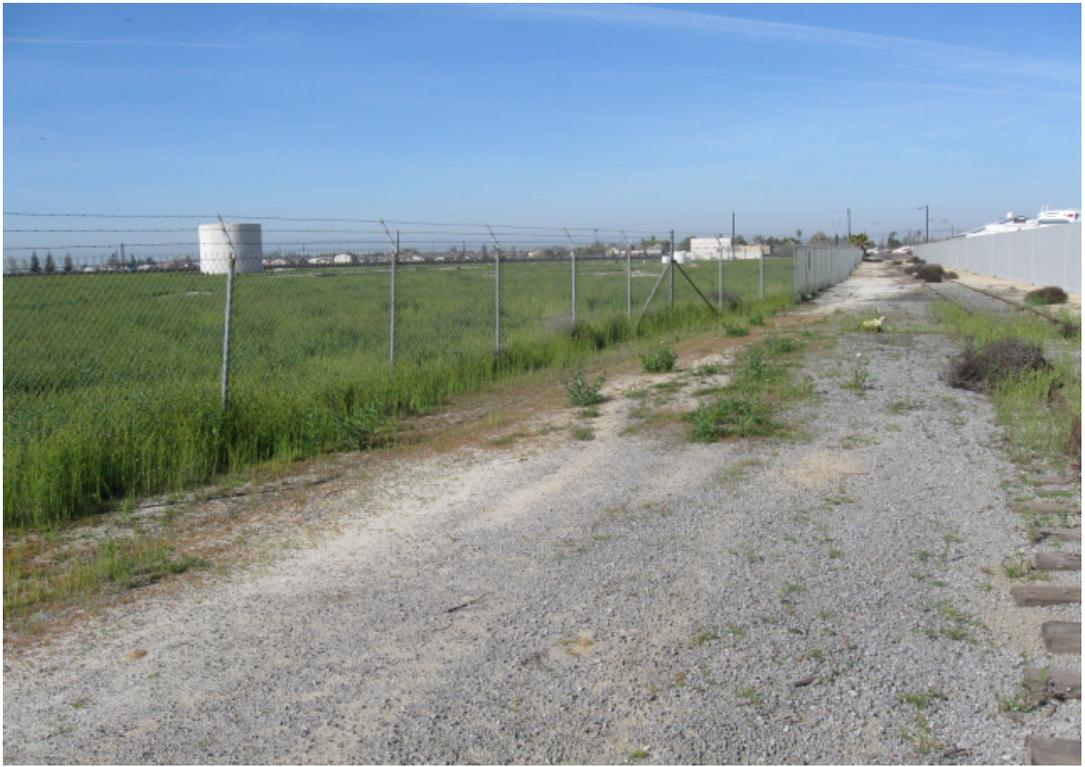
<p>Photo No. 5</p>

<p>Direction Photo Taken: Looking west</p>	
<p>Description: View of the north side of the site from the northeast corner. Note the offsite rail spur in the right of the frame.</p>

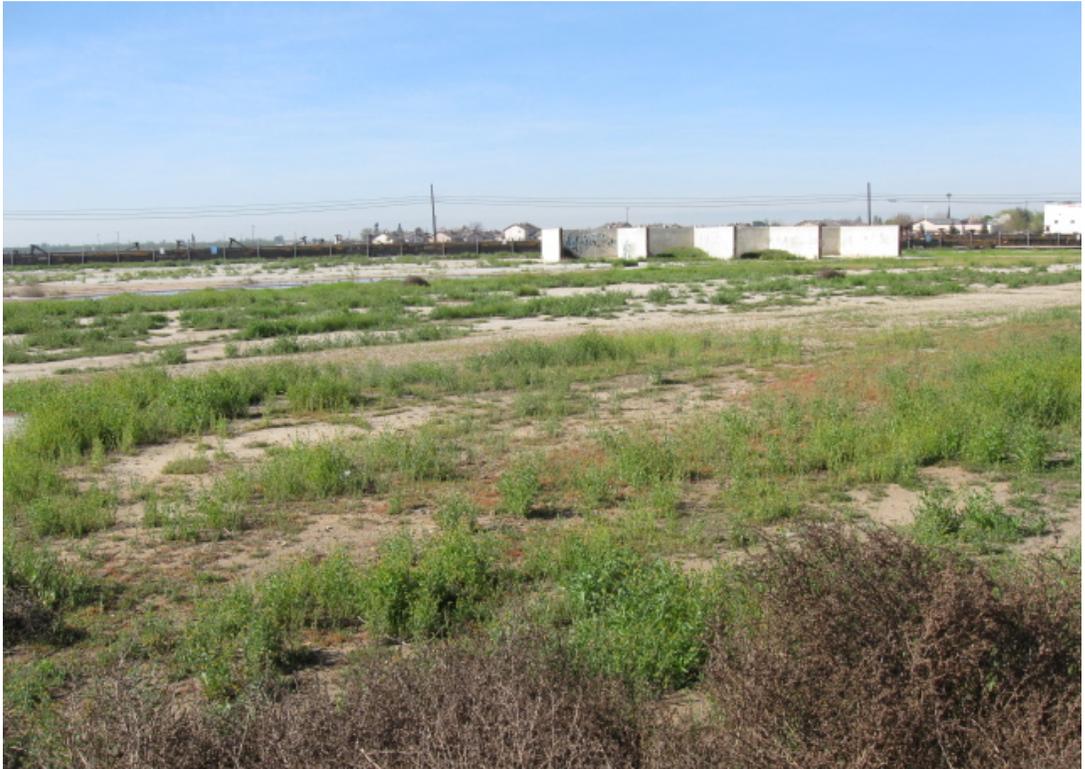
<p>Photo No. 6</p>

<p>Direction Photo Taken: Looking west</p>	
<p>Description: View of the west side of the site and the only remnants of structures. Note the flatbed rail cars on the BNSF tracks beyond the site.</p>

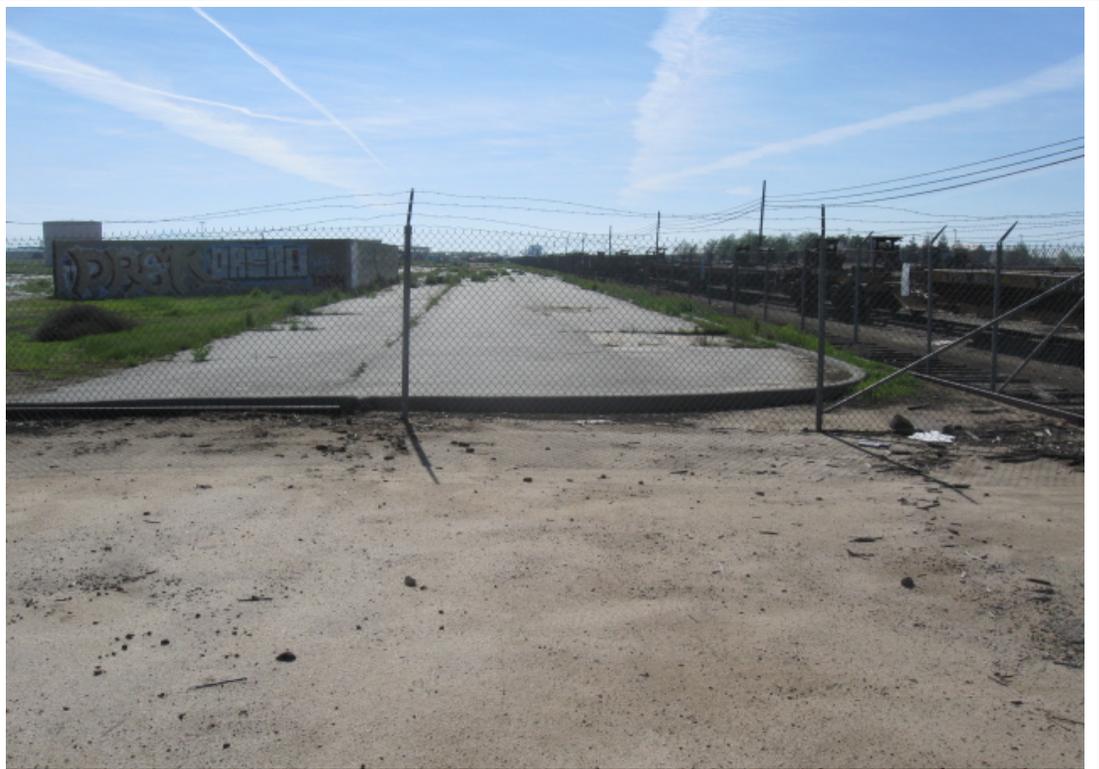
<p>Photo No. 7</p>
<p>Direction Photo Taken: Looking southeast</p>
<p>Description: View of the west side of the site along the BNSF tracks. Note concrete block walls (see Photo 6).</p>

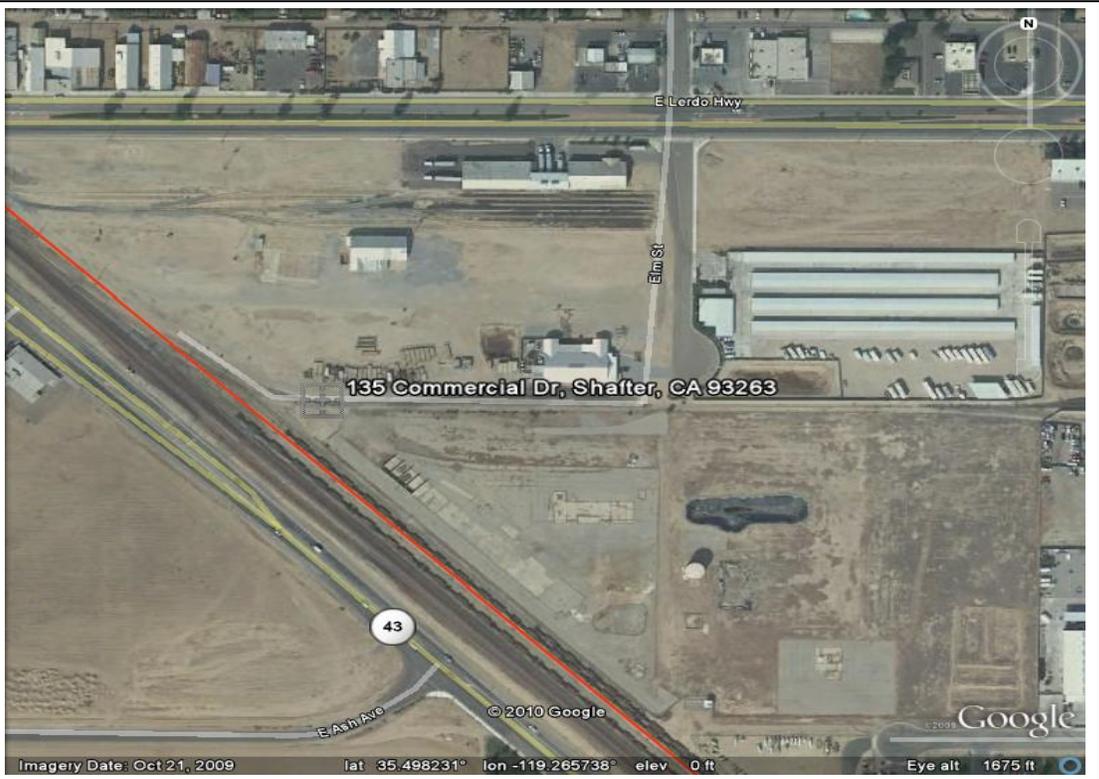
<p>Photo No. 8</p>
<p>Direction Photo Taken: Aerial view</p>
<p>Description: B&B site (area south of Commercial Dr). Note plastic lined pond and AST. Concrete wall structure is also visible on the west end. The proposed CAHST alignment is the red line parallel to Hwy 43. NOTE: Google Earth Imagery dated 10/21/09; Google Earth website accessed 3/17/10.</p>
